TALBOT'S TOWER

Kilkenny

Conservation Report Completion of 2012 Works

November 2012

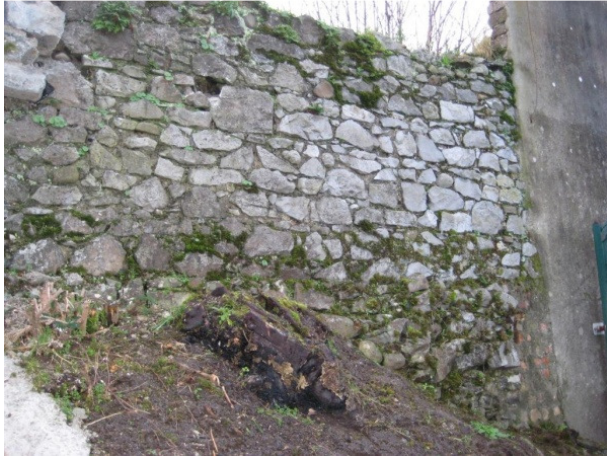
The section of north curtain wall before work started. Works undertaken included removal of vegetation, repair of wall top and some repointing.

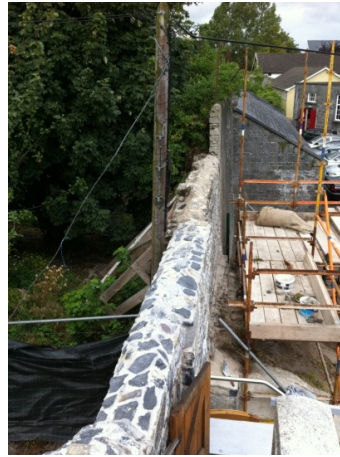
View of the repaired wall top.

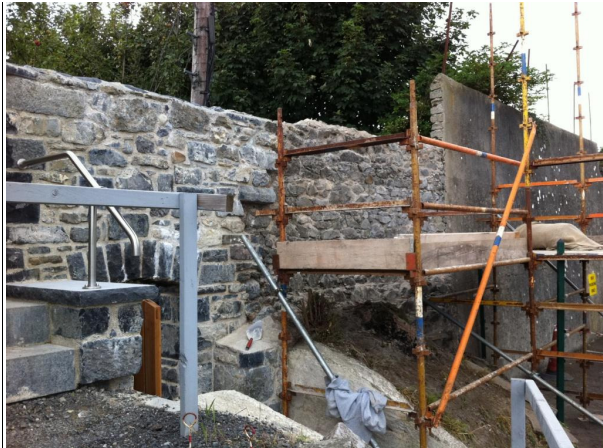
Repointing work underway

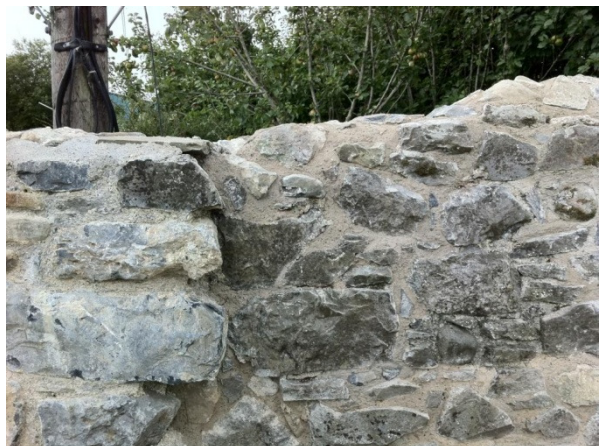
Detail of the repointing work. Samples of sand and exemplars of pointing were agreed in advance.

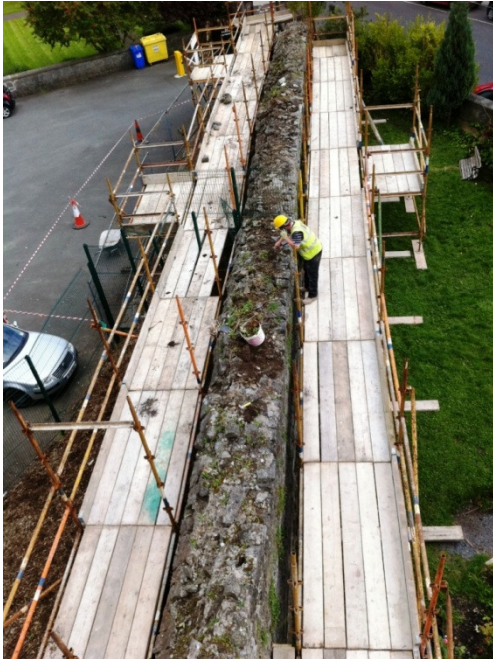
View of the east curtain wall scaffolded and ready to commence work.

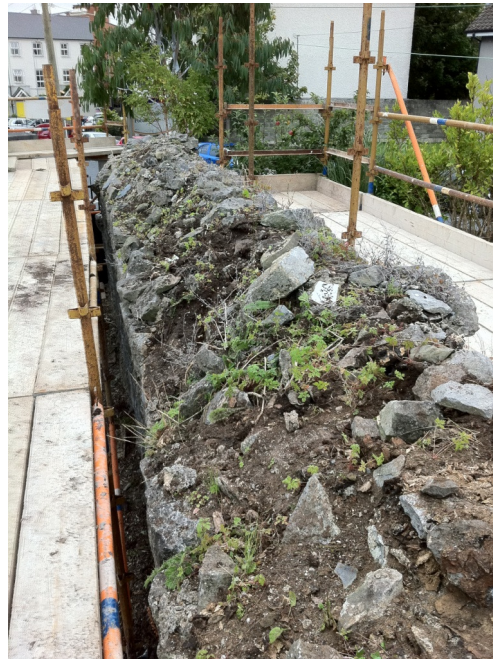
There was extensive vegetation and soil on the wall top. This was carefully removed.

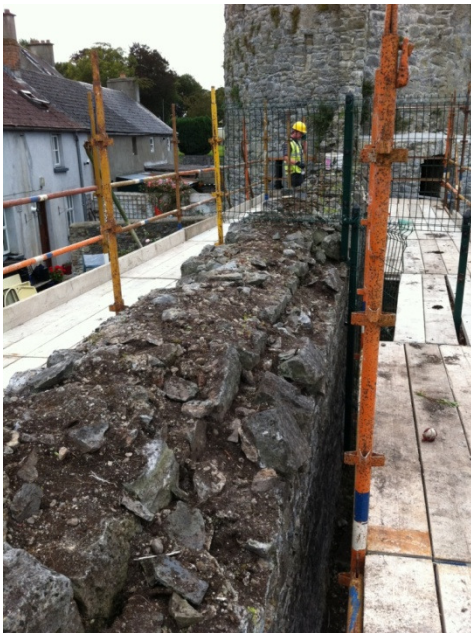
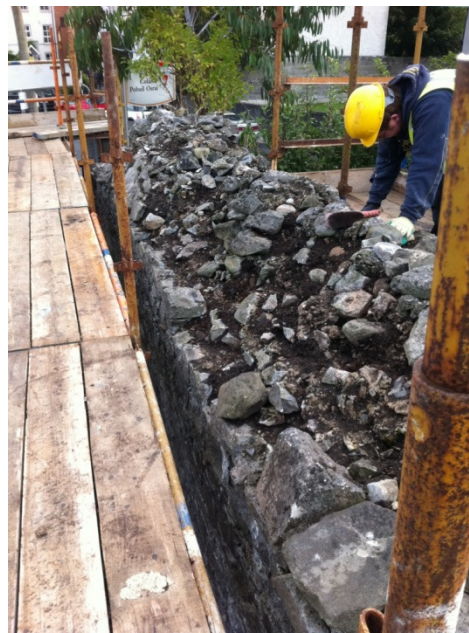
Two images of work underway on the east wall

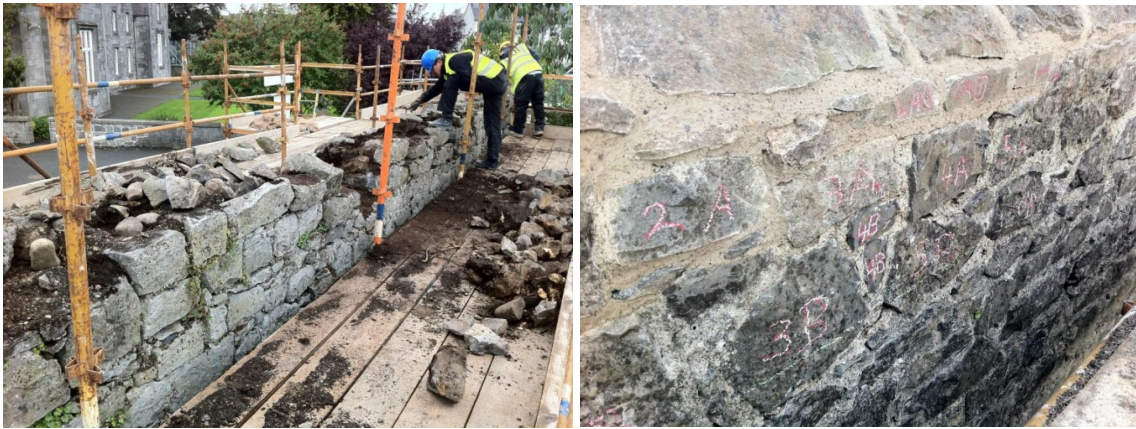
The wall was surveyed. Stones were numbered and removed in small batches before being rebuilt.

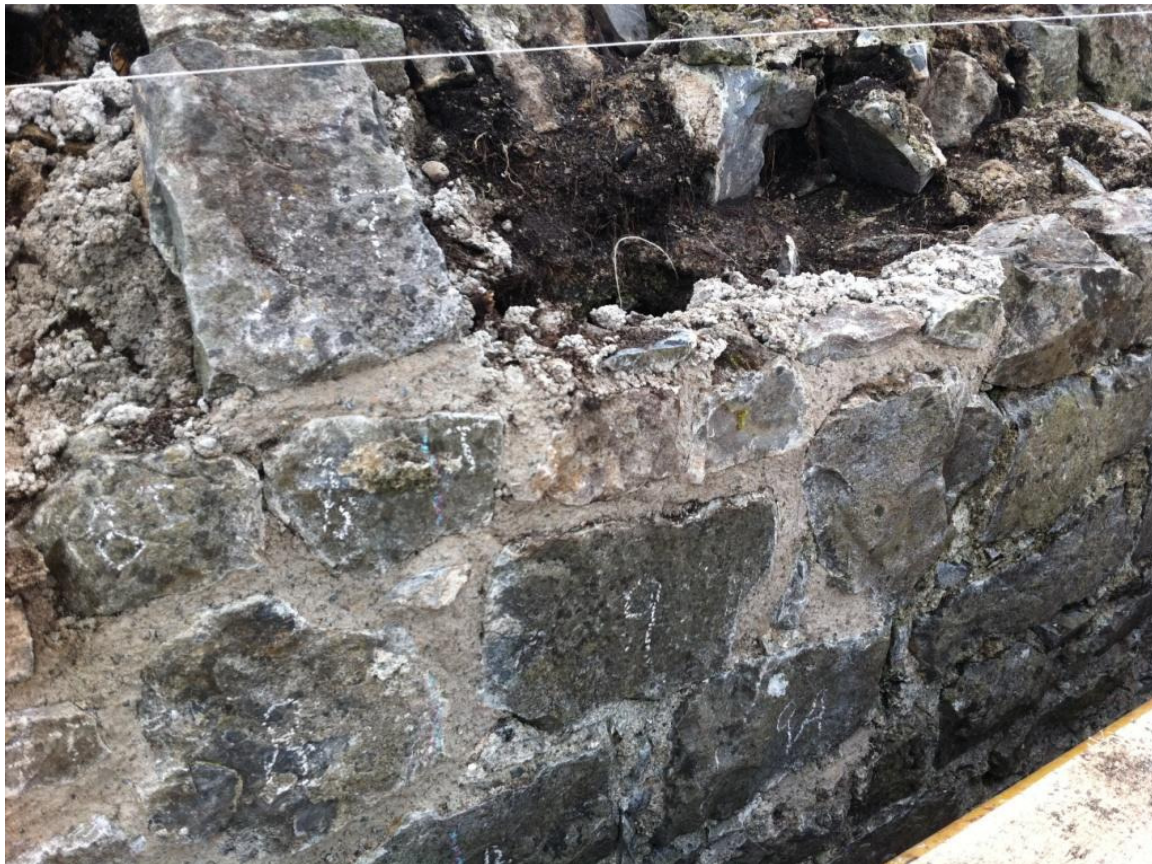
Victorian facing stones are numbered removed and reinstated

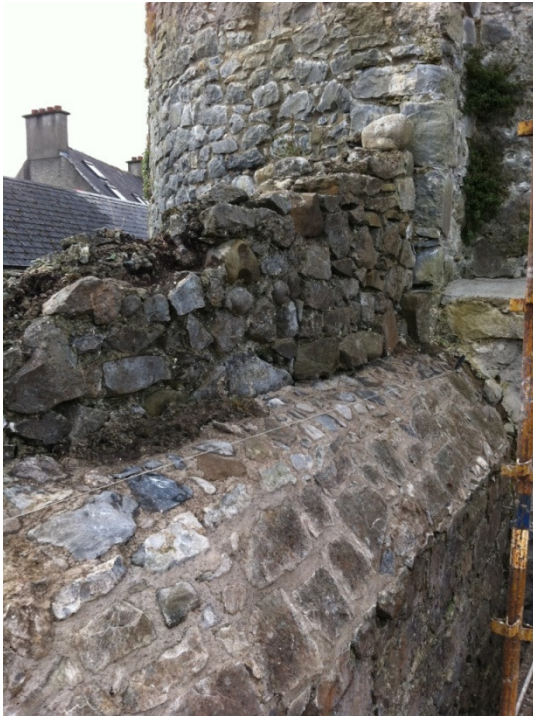
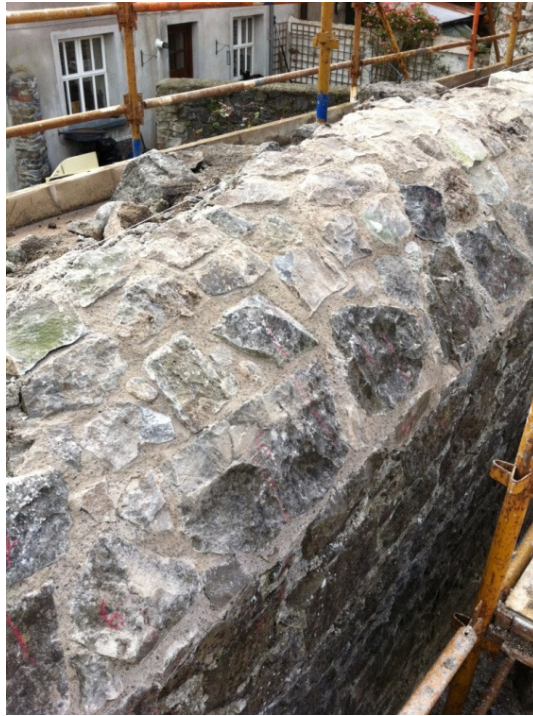
Detail of the completed wall top.

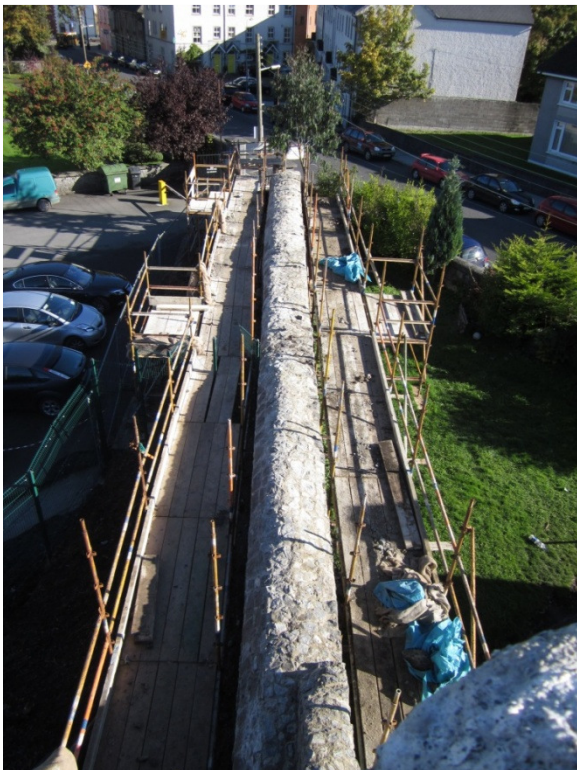
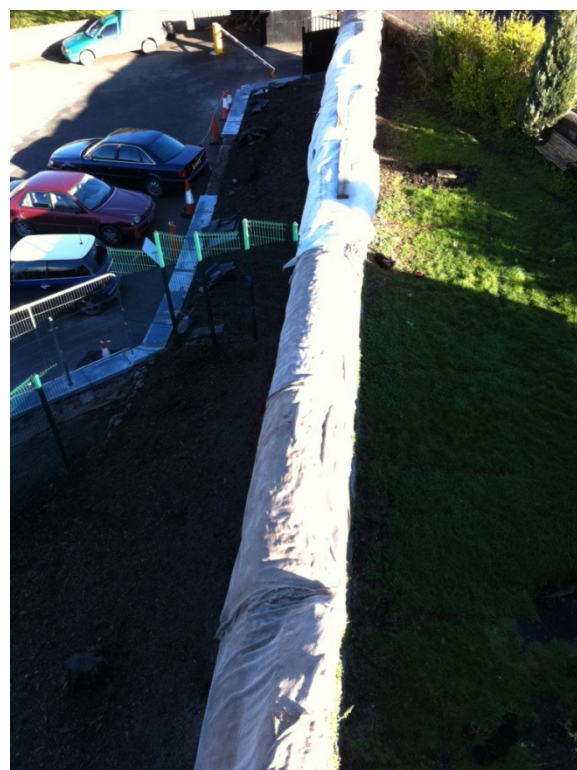
The completed wall top left, and right, protected from inclement weather

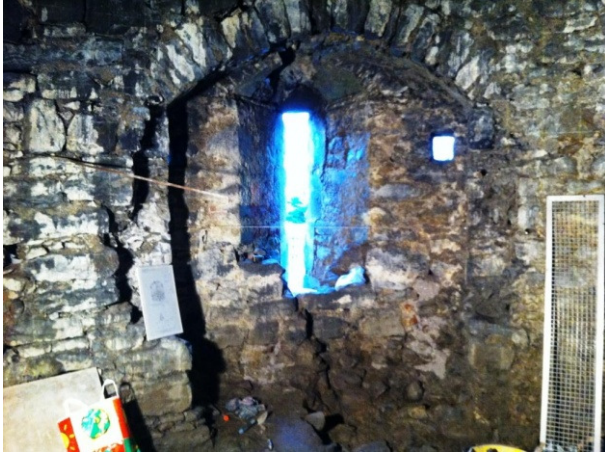
Loop No. 145. Surveying underway, before rebuilding commences

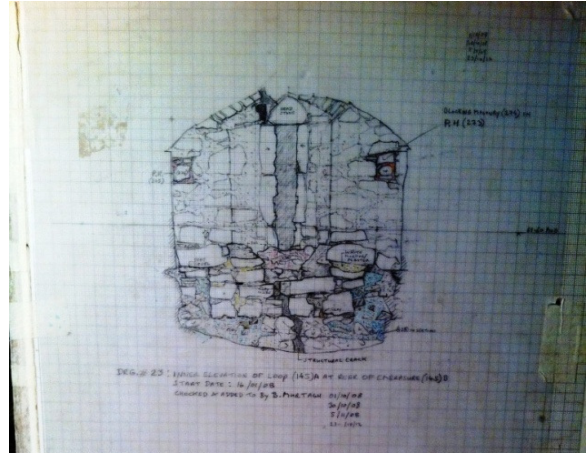
Survey of Loop No. 145 by archaeologist on site

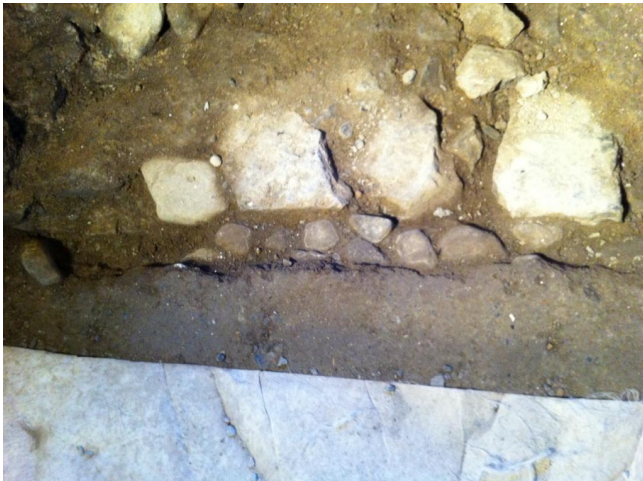
The original footing and cobble floor was uncovered during excavation

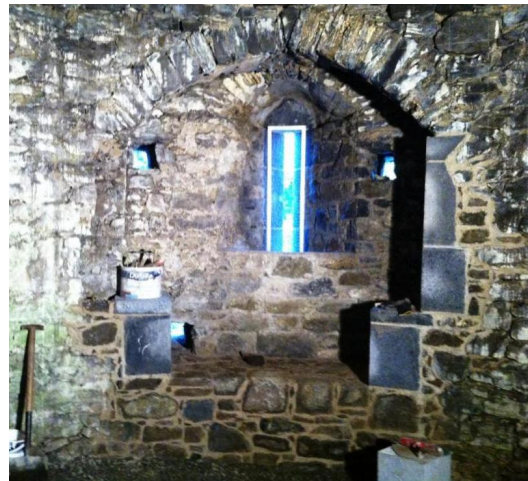
Loop No. 155. Rebuilding of window seats is based on archaeological evidence.

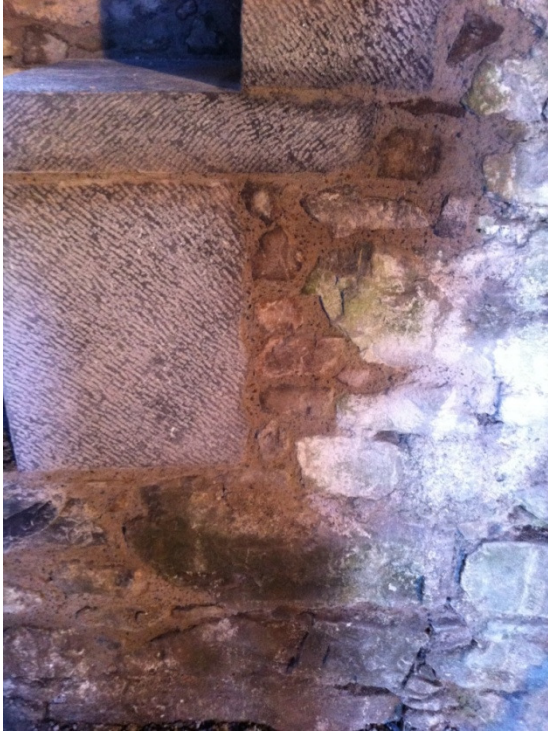
Loop No. 135. Detail of stone tooling and adjacent rubble stonework

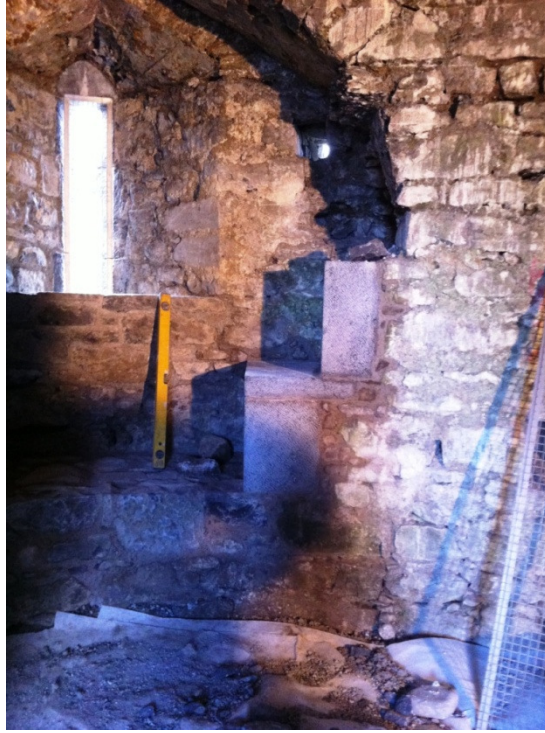
Loop No. 135 during rebuilding of stone seats

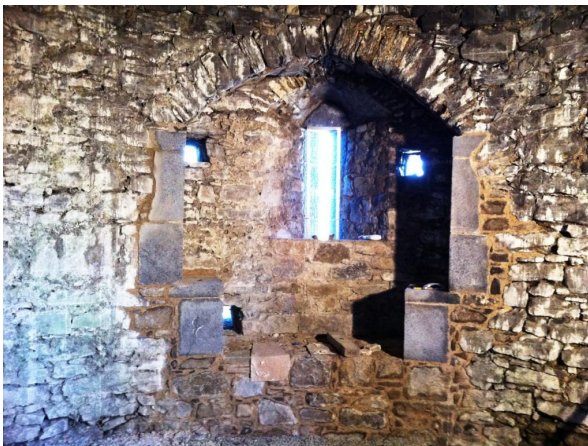
Loop 155 completed

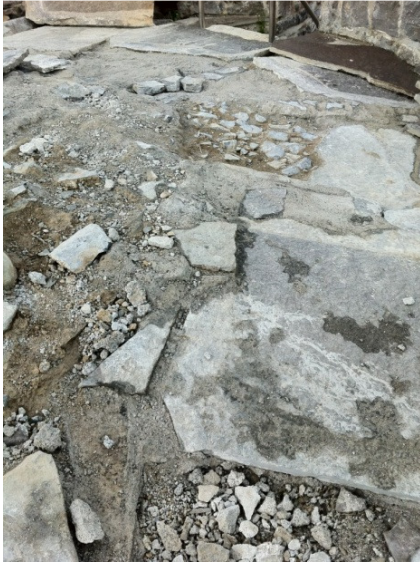
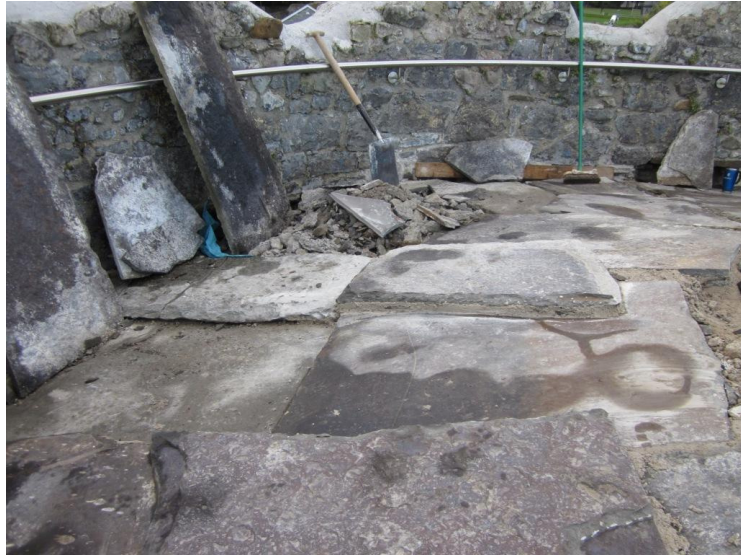
The roof has been stripped back. Original flags remain in situ. New flags have been matched and re-laid in a lime bed.

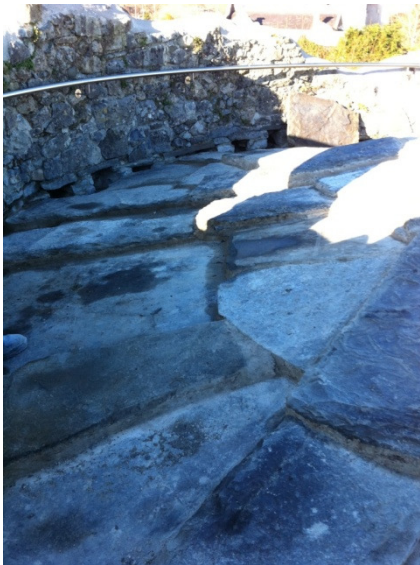
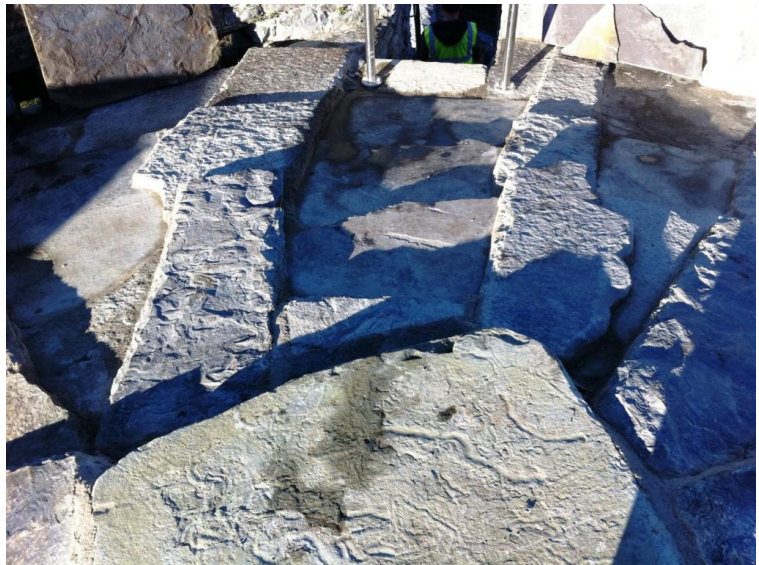
The roof has been stripped back. Original flags remain in situ. New flags have been matched and re-laid in a lime bed.

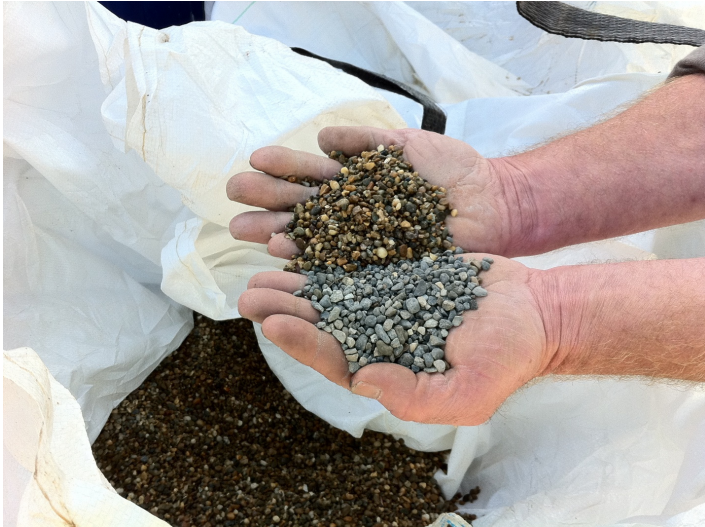
Samples of aggregate on site before work commenced.

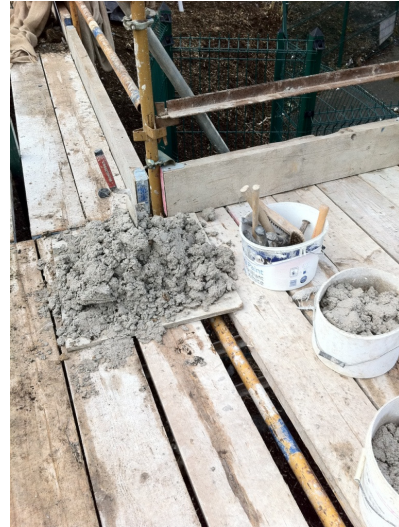
Fresh mortar ready for application

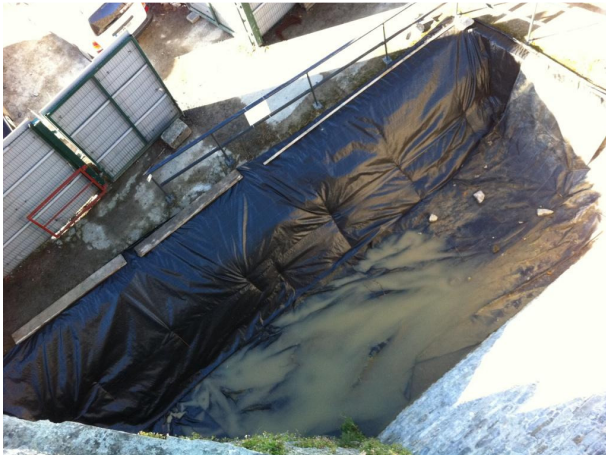
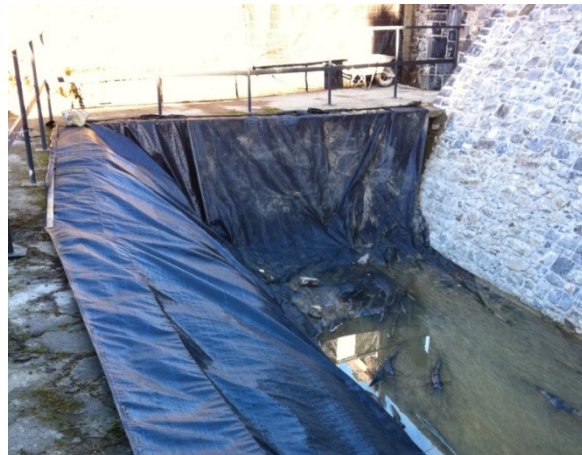
The ditch will be completely protected over the winter with heavy duty membrane, fixed at the top and pinned into the face of the ditch.
