**PROPOSED NEW BUTLER GALLERY AT
EVAN'S ALMS HOUSE,
BARRACK LANE, KILKENNY**

**VOLUME 2: ADDENDUM
INTERNAL SCHEDULE OF DEFECTS**

July 2010

Prepared for McCullough Mulvin Architects

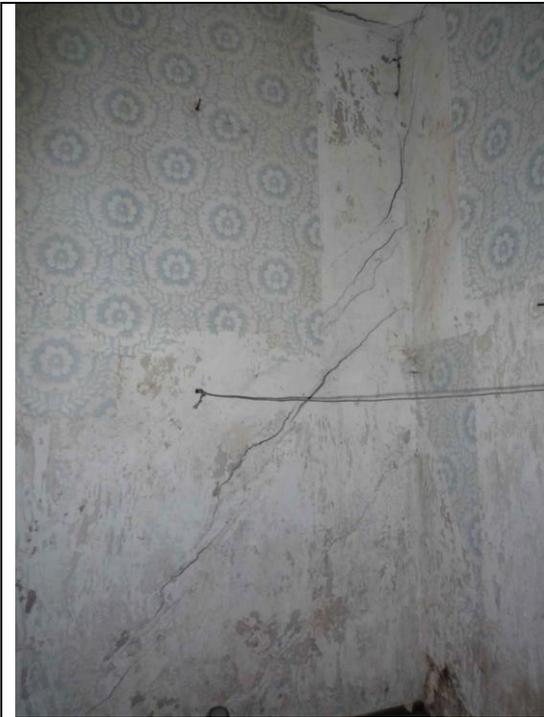
Diagonal cracking of plaster to north wall corresponding with external cracking.	Structural engineer to investigate & underlying causes to be addressed prior to repair of plasterwork. Cracks to be caulked with a mixture of lime putty and casting plaster.
	Delamination of plaster to north and east walls.	Rake-out cement based strap pointing to external walls. Re-point and re-harl external walls in a lime based material. Rationalise external drainage and introduce a French drain to reduce likelihood of rising damp. Cap chimney flue to prevent the ingress of rainwater while allowing adequate ventilation. Replace damaged/missing sections of plaster with a lime based plaster to match existing.
Ceiling	Localised hairline and larger cracks running northwest-southeast.	Cracks to be caulked with a mixture of lime putty and casting plaster.

Fig.1: Cracking of plaster to the north wall corresponding with cracking to the external wall.

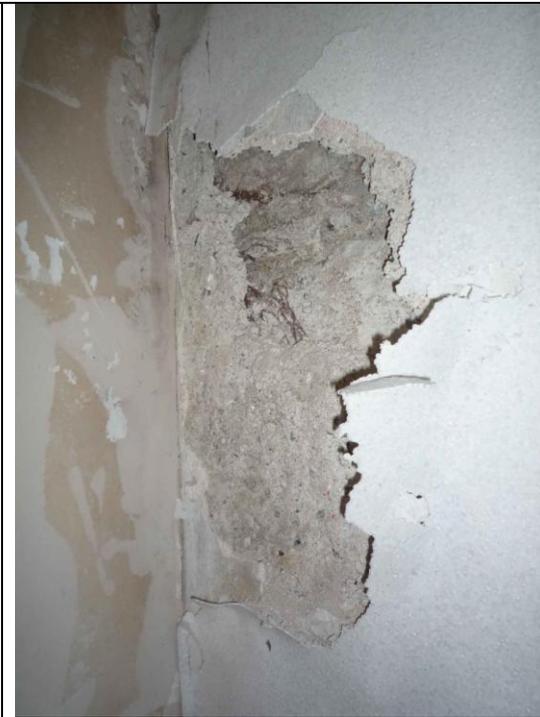
Fig.2: Delamination of wall plaster likely to have been caused by application of cement based pointing to the external elevation.

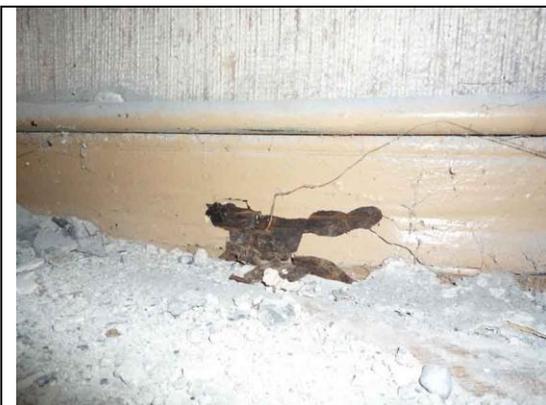
Fig.3: Timber decay to skirting board (north wall).

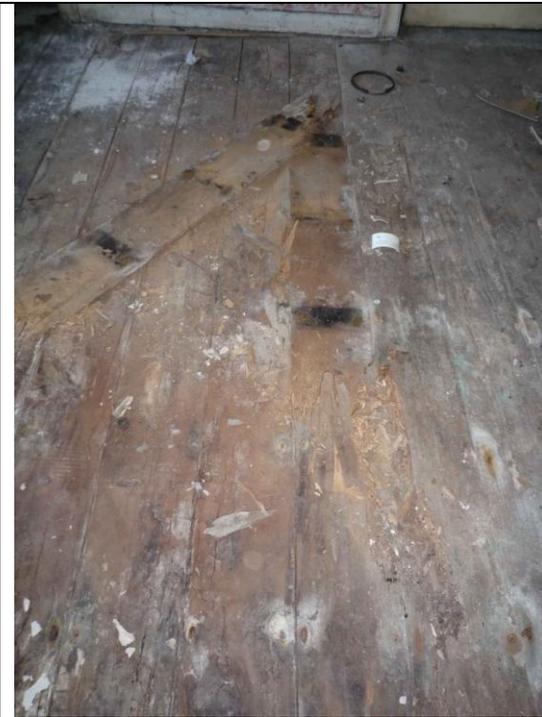
Fig.9: Significant decay to modern timber floor.

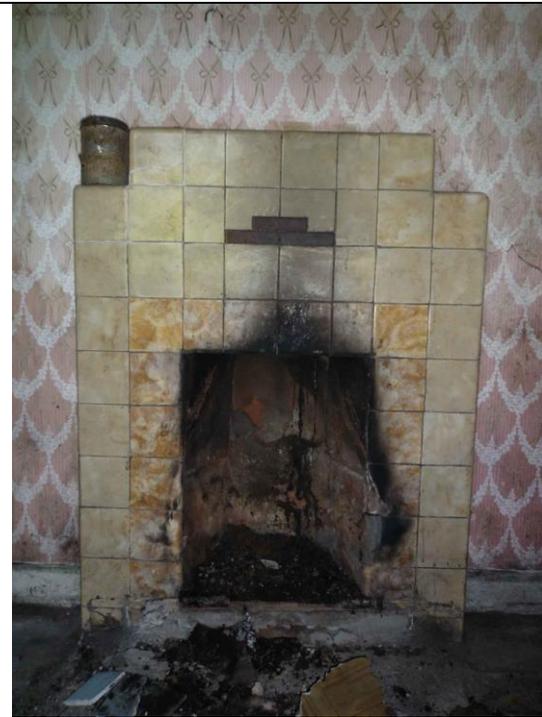
Fig.10: Modern 20th century tiled fireplace.

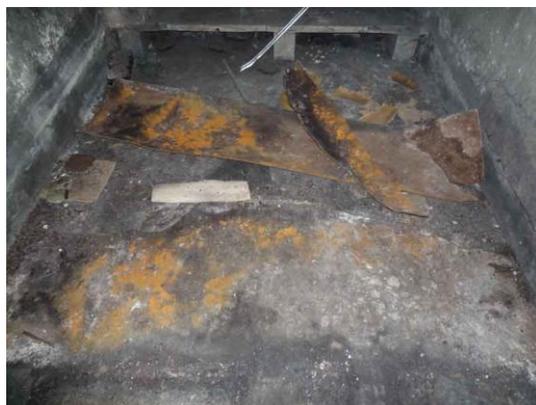
Fig.11: Concrete floor to room G06.

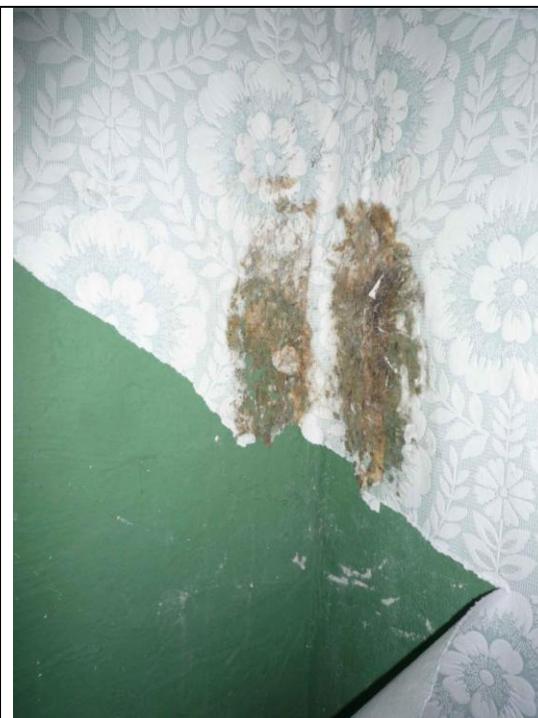
Fig.14: Rising damp at low level to walls.

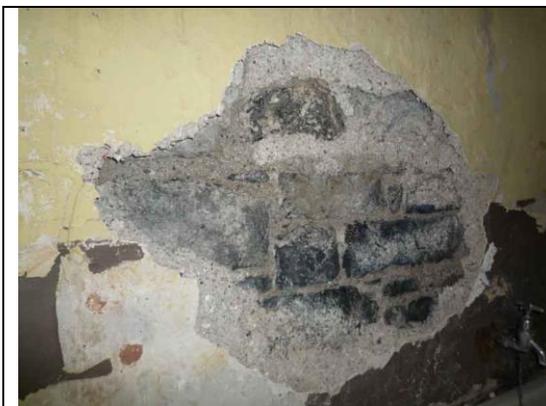
Fig.15: Missing plaster to the south wall.

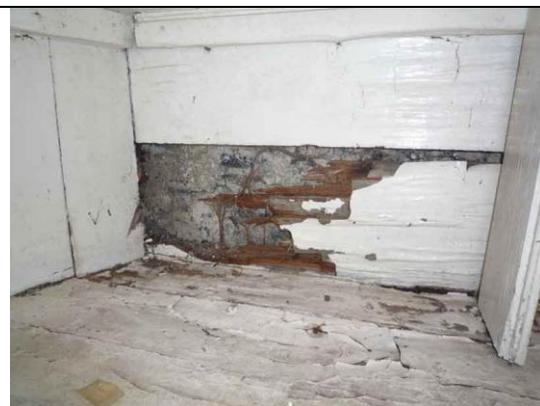
Timber decay to window back of westernmost window opening.	Cut out decayed timber and splice in new timber to match existing.
Rising Damp	Rising damp to walls.	Rake-out cement based strap pointing to external walls and re-point in a lime based material. Re-harl all external walls in a lime based material. Rationalise external drainage and introduce a French drain to reduce likelihood of rising damp. Gradually introduce heating to the building ensuring adequate ventilation of all rooms.
Other	Belfast sink.	Consideration should be given to retaining this feature as part of the historic fabric of the building.
	Electric board.	Rationalise services within the building and consider relocating electricity manifold to either G06, G07, G09 or G10.

Fig.16: Timber decay to window back of westernmost window opening.

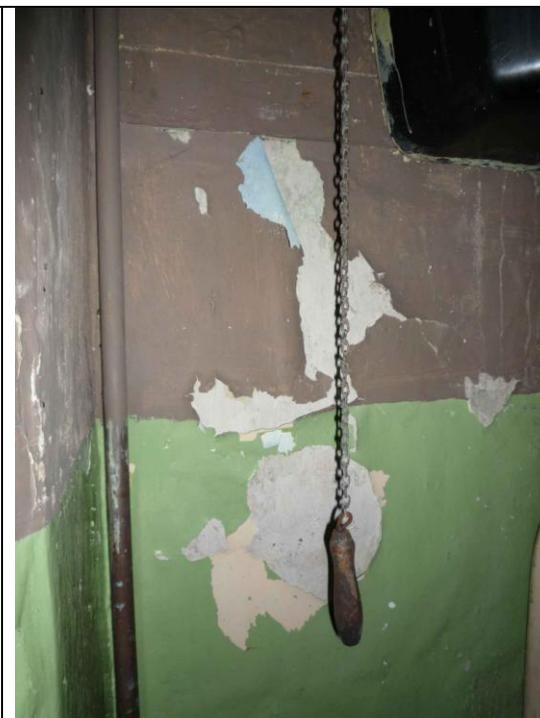
Fig.18: Plaster and paint failure to the south wall.

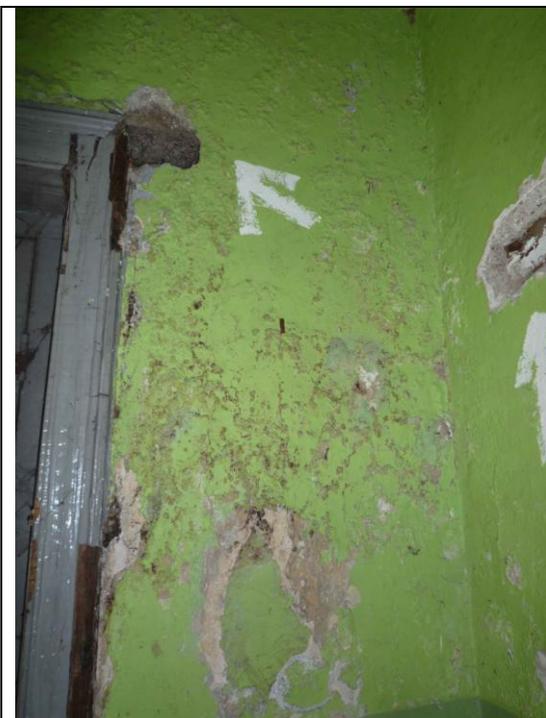
Fig.21: Failure of plaster to the west likely to have been caused by the ingress of moisture through open-joints in the external door surround.

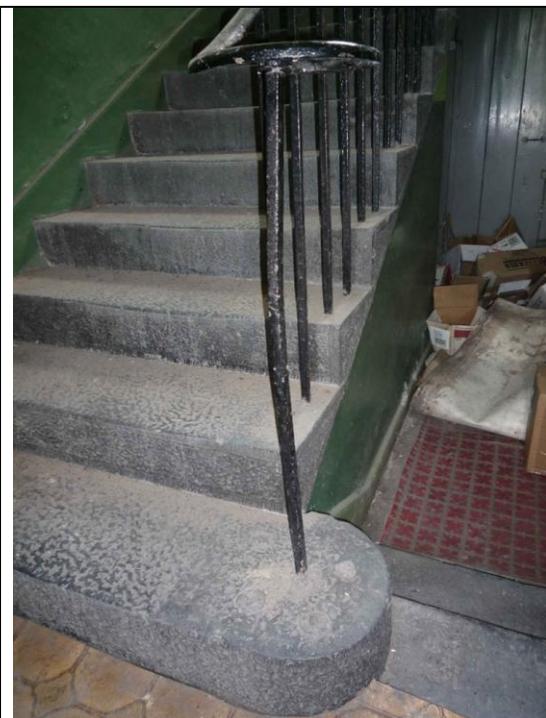
Fig.22: Missing wrought-iron balusters newel post of staircase.

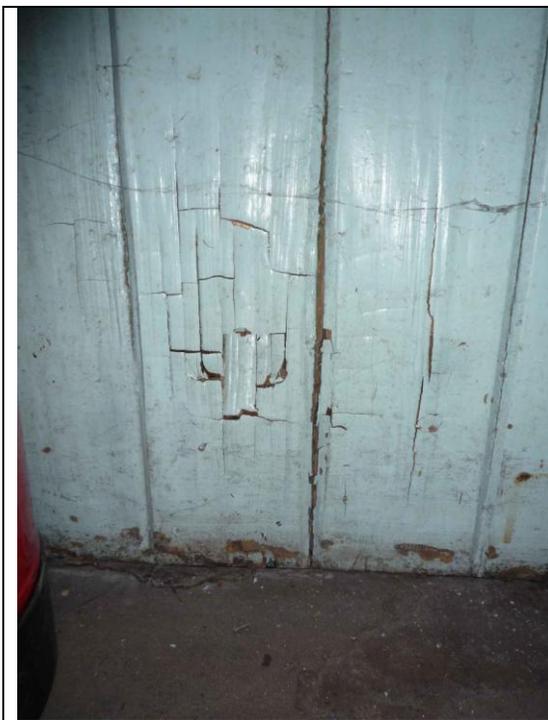
Fig.23: Timber decay at low level wainscoting.

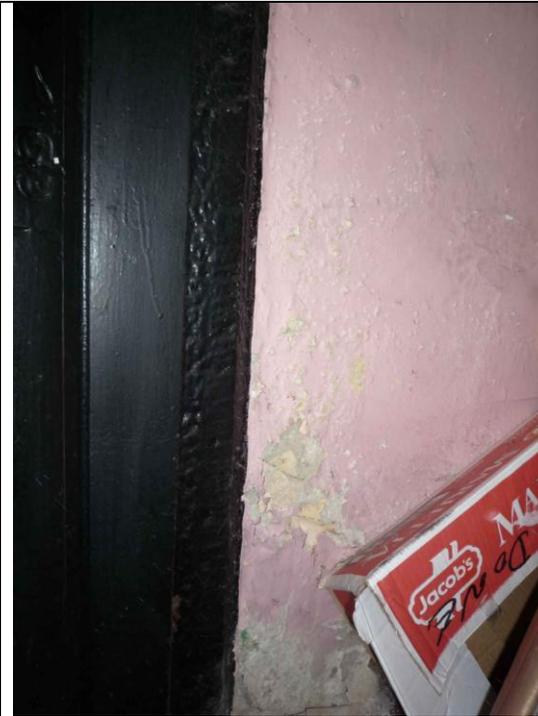
Fig.26: Efflorescence and plaster failure to chimney breast likely cause by penetrating dampness via the open flue.

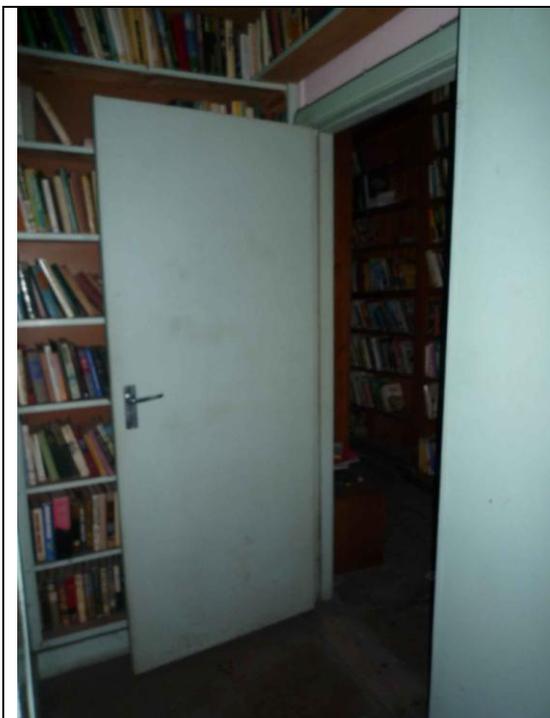
Fig.27: Partially blocked opening to the south wall. Note the inappropriate flush panelled door.

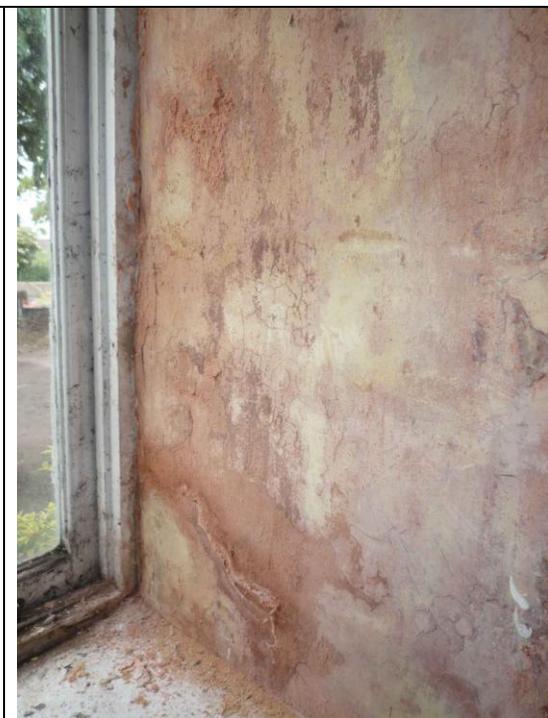
Fig.28: Failure of the plaster to the east window opening.

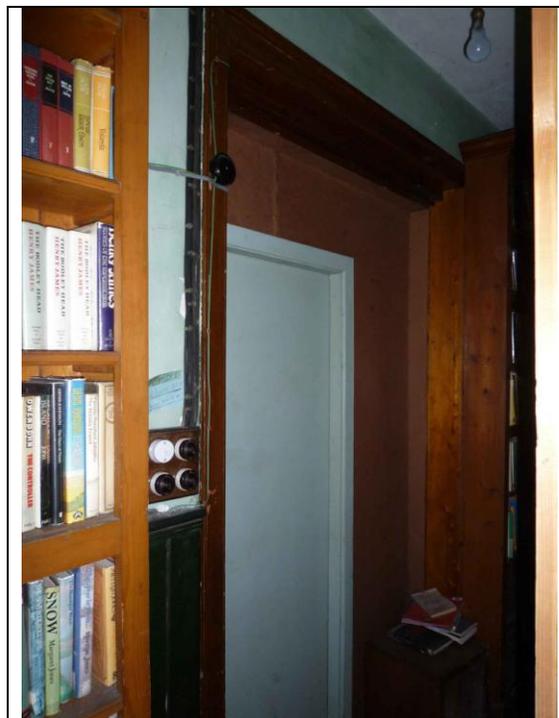
Fig.29: Altered door opening with modern flush panel door.

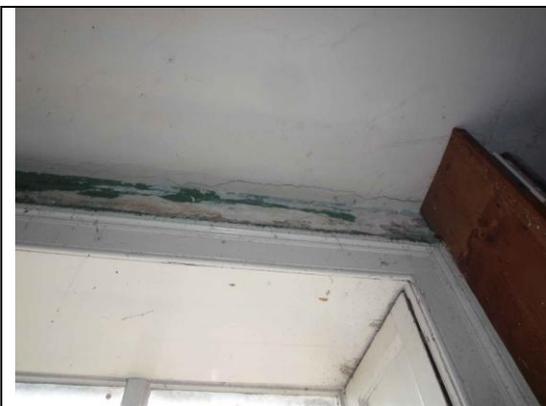
Fig.30: Plaster failure at high level to the west wall.

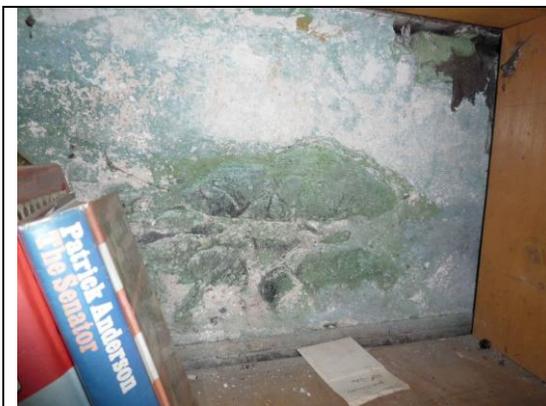
Fig.32: Plaster failure and efflorescence to east wall.

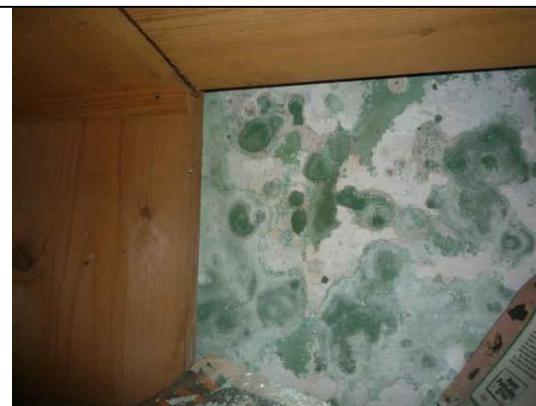
Fig.33: Plaster failure and efflorescence at junction of south and east wall.

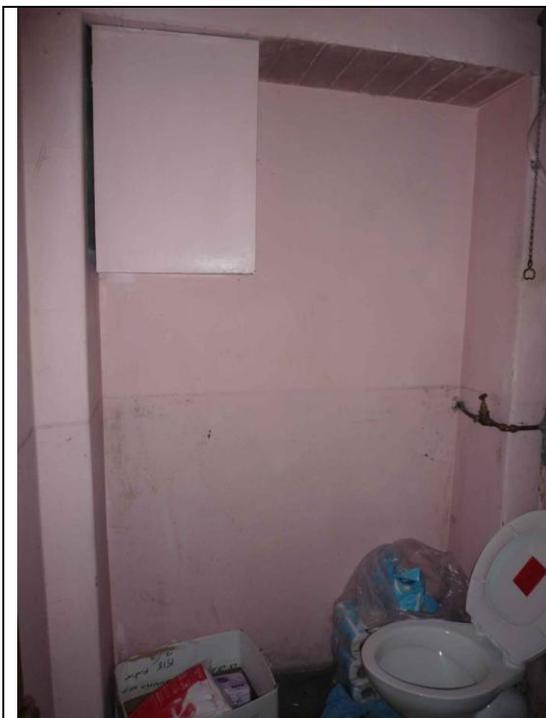
Fig.34: Blocked former door opening in the south wall.

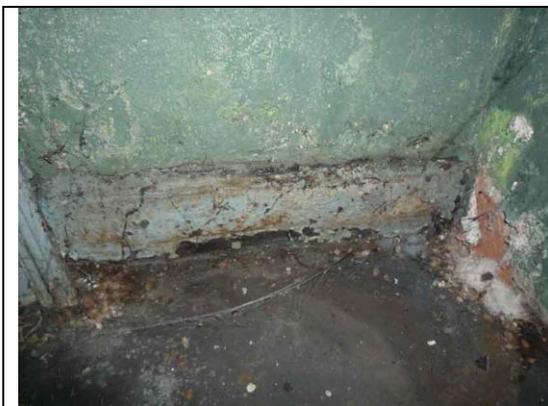
Fig.36: Timber decay to timber skirting to east wall.

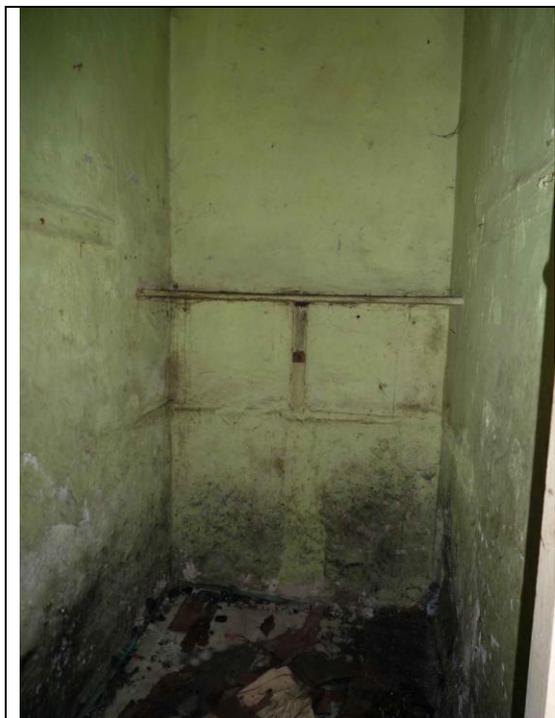
Fig.38: Plaster failure to low level as a result of rising damp.

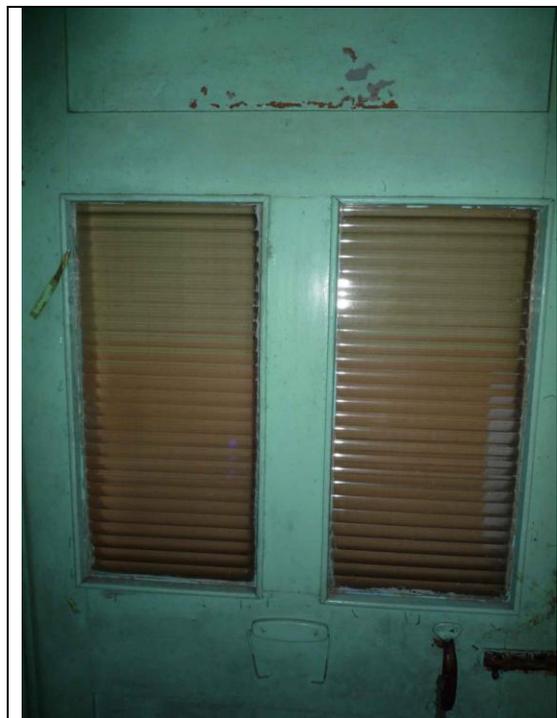
Fig.39: Glazed panels to the door giving access to G08.

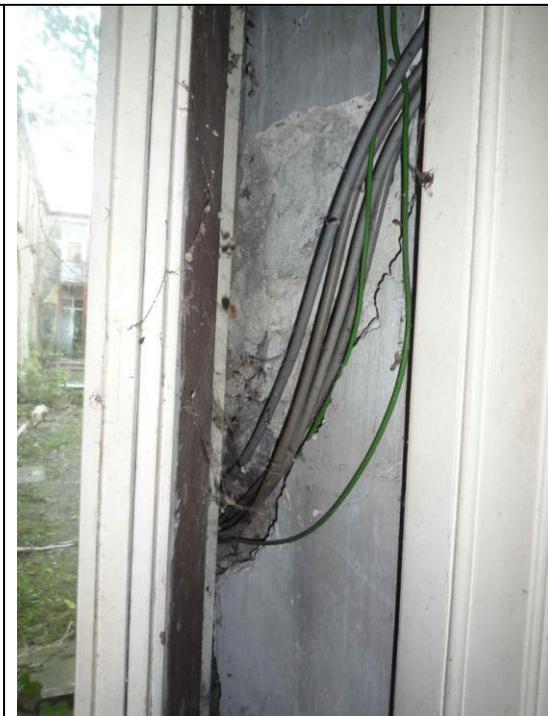
Fig.41: Timber decay to window back of westernmost window opening.

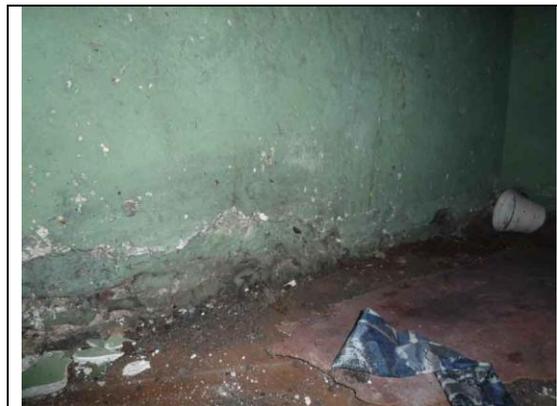
Fig.42: Rising damp to the north wall.

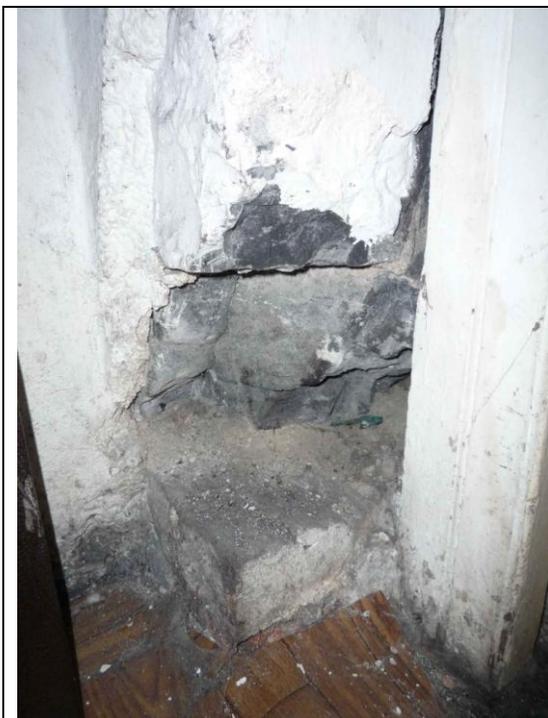
Fig.43: Missing masonry at door jamb.

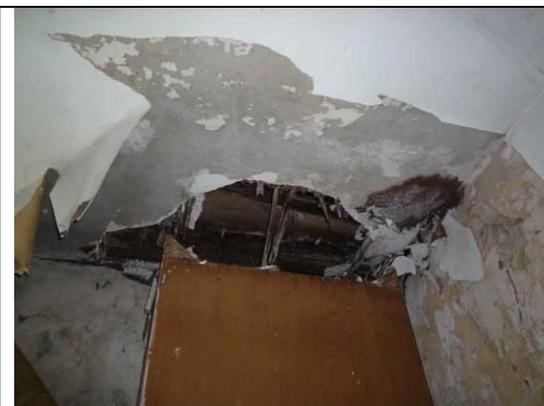
Fig.47: Hole in ceiling plaster to southwest corner.

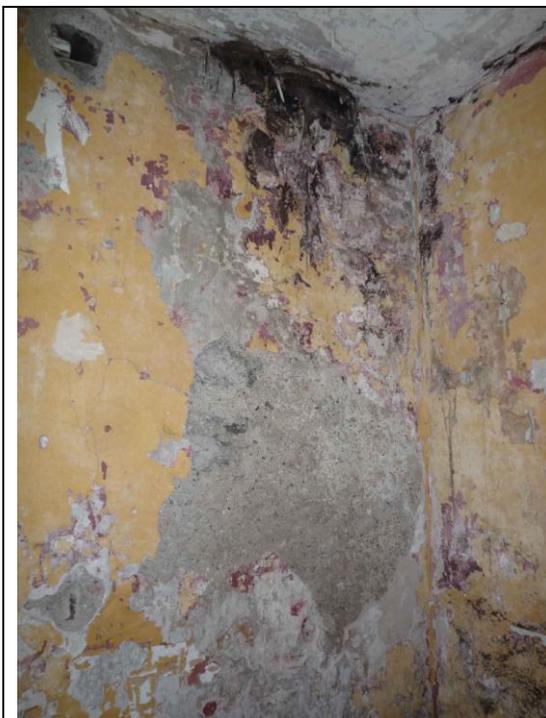
Fig.49: Plaster failure and fungal growth to the east wall.

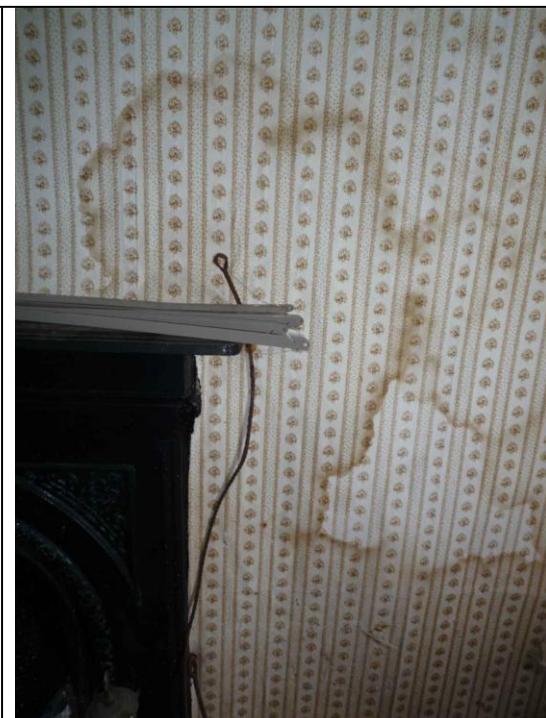
Fig.50: Soot staining to chimney breast associated with penetrating damp.

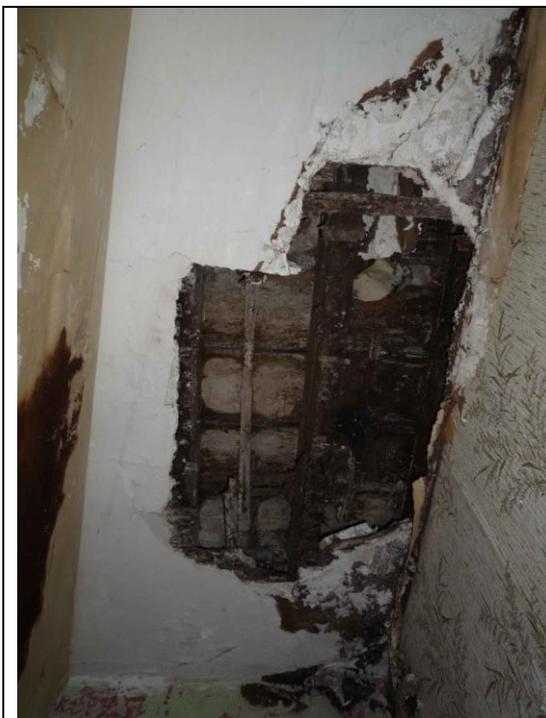
Fig.51: Missing plaster to ceiling to southeast corner of G28.

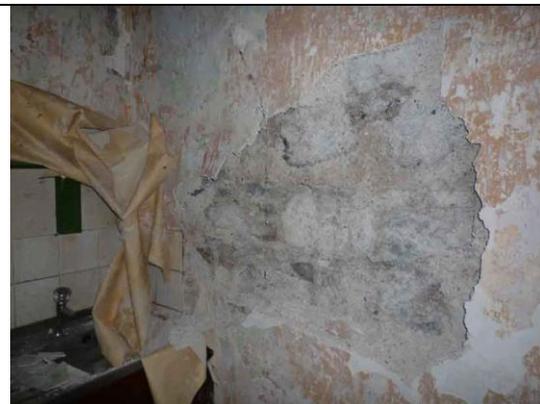
Fig.53: Plaster failure to the west wall of G29.

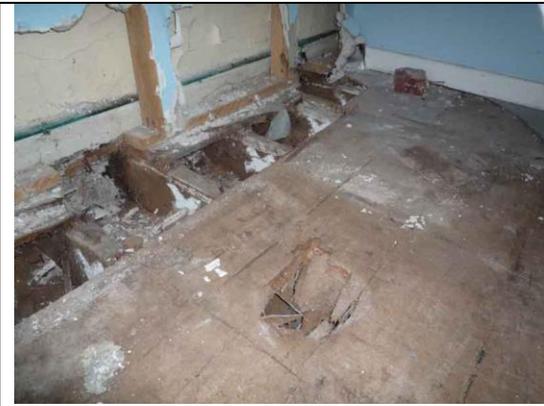
Fig.55: Missing floorboards to the west of F01.

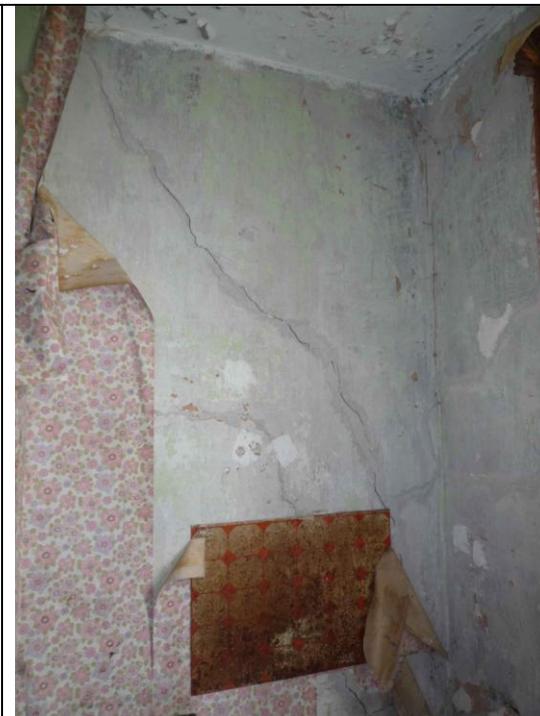
Fig.58: Cracking of plaster to the west wall.

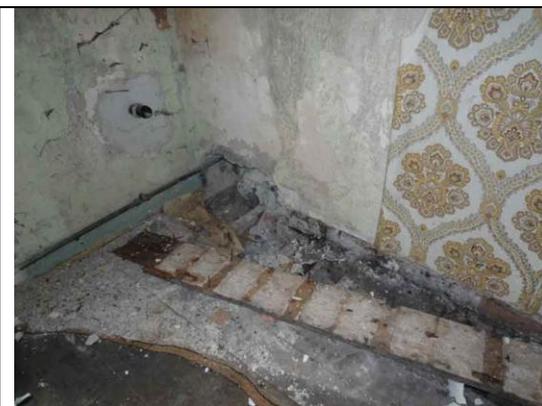
Fig.59: Missing floorboards to the east elevation.

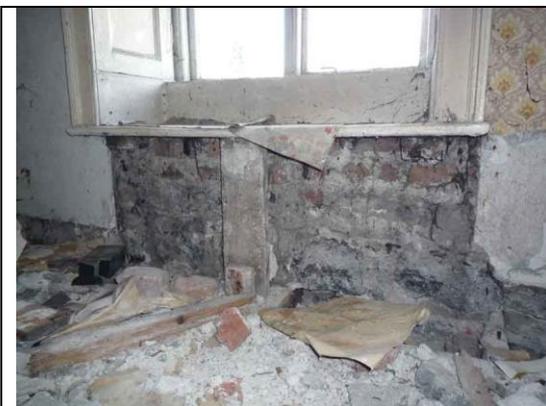
Fig.63: Missing apron panel to window opening.

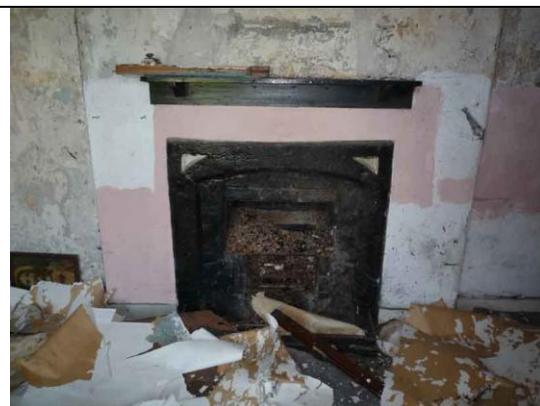
Fig.64: Over-painted stone surround to fireplace.

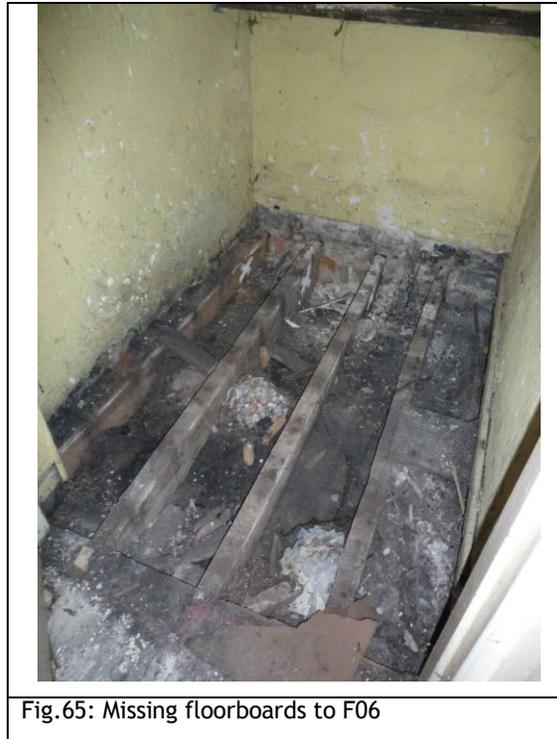
Fig.65: Missing floorboards to F06

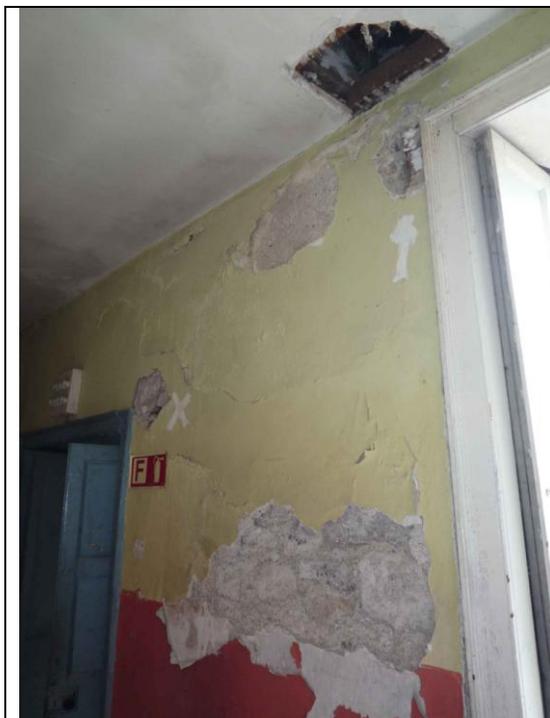
Fig.67: Failure of plaster to the south wall.

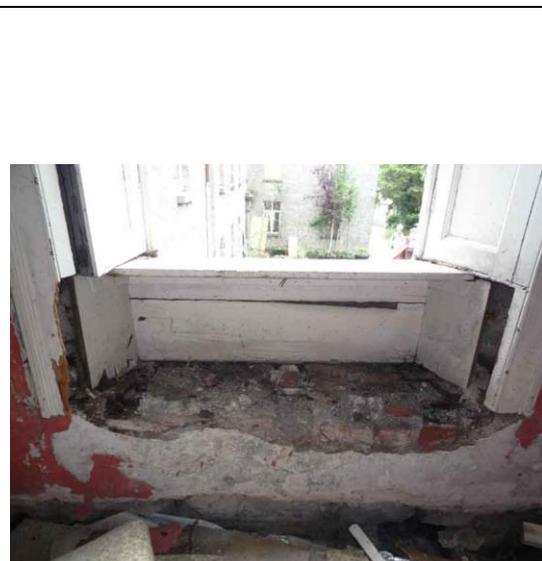
Missing timber sill, section of architrave and window back to westernmost window opening.	Replace missing sill, architrave and window back in timber to match existing.
Other	Belfast sink.	Consideration should be given to retaining this feature as part of the historic fabric of the building.

Fig.68: Missing sill, section of architrave and window back to westernmost window opening.

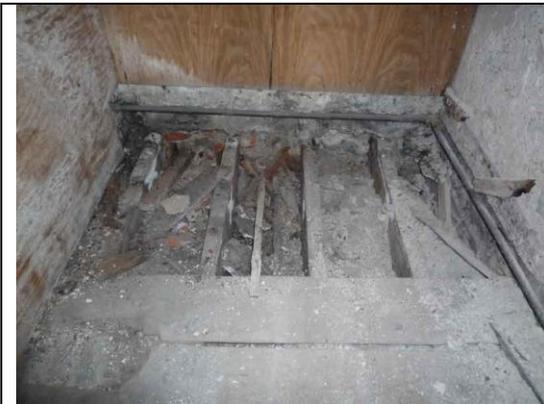
Fig.70: Missing floorboards to the south of room F10.

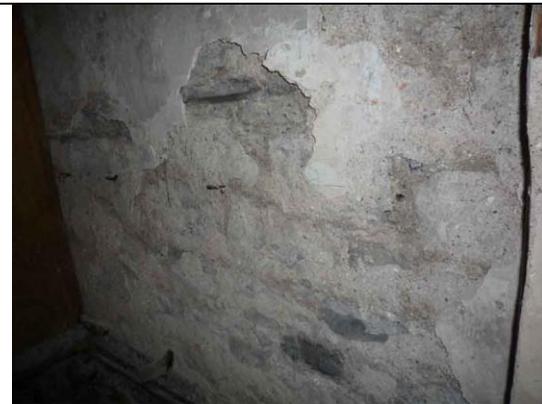
Fig.71: Failed plaster to the west wall.

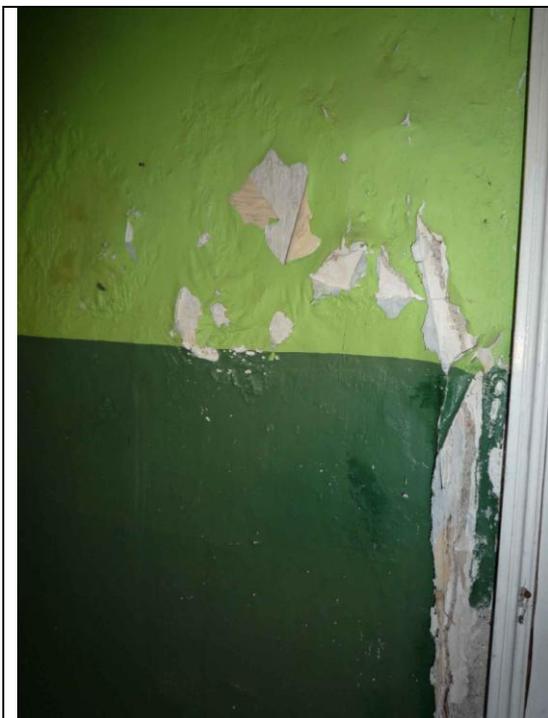
Fig.72: Plaster and paint failure to the west wall.

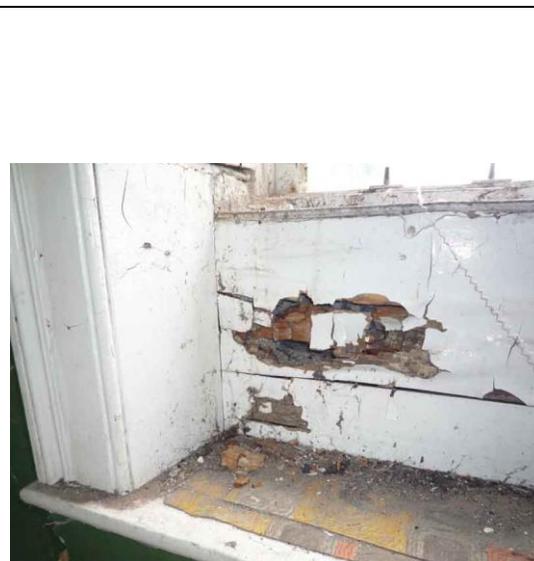
Fig.73: Timber decay of window back to west window opening.

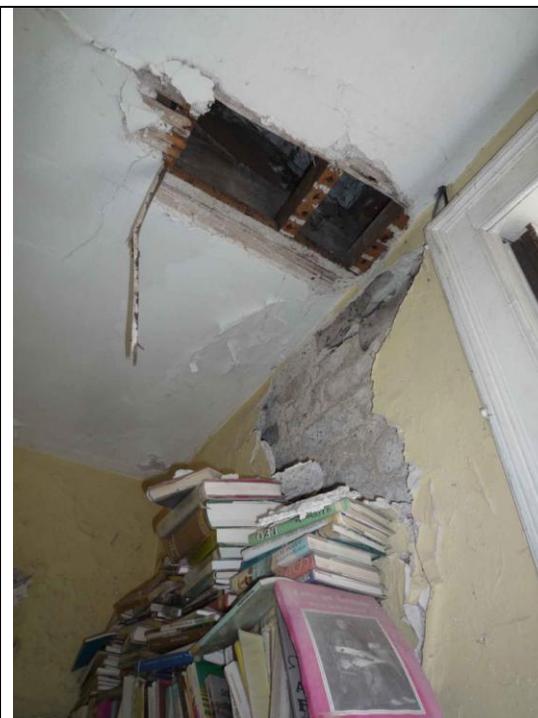
Fig.75: Damaged ceiling plaster adjacent the window opening.

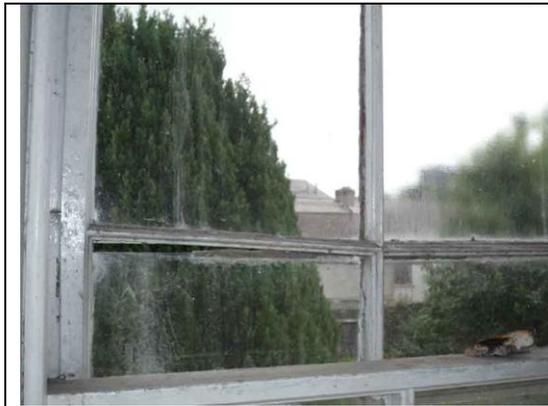
Fig.76: Timber decay to glazing bar of window - note the glass pane has slipped.

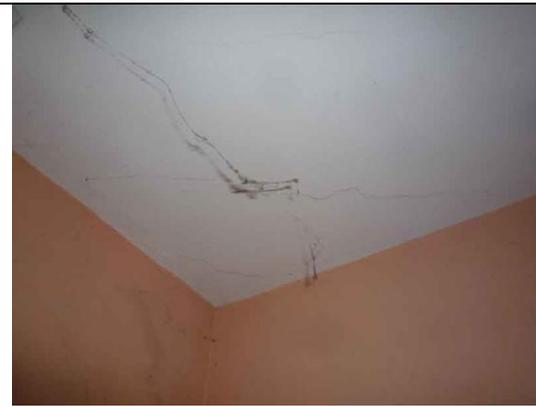
Fig.77: Cracking of ceiling plaster to the southwest corner.

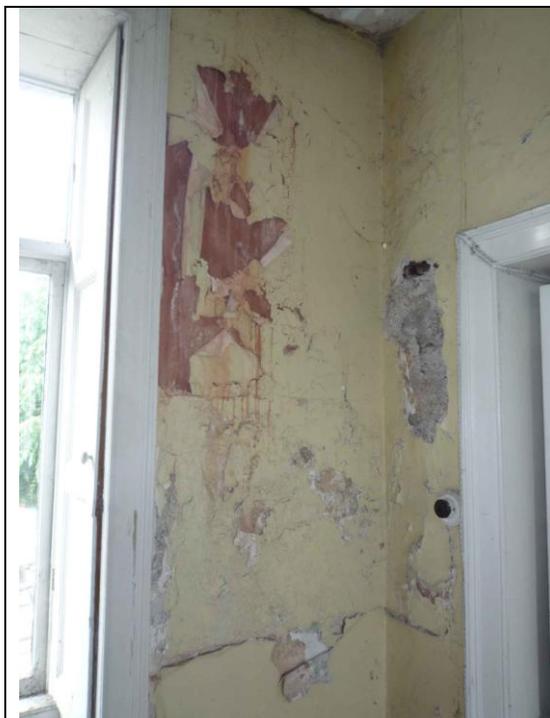
Fig.78: Failure of wall plaster to the north and west walls.

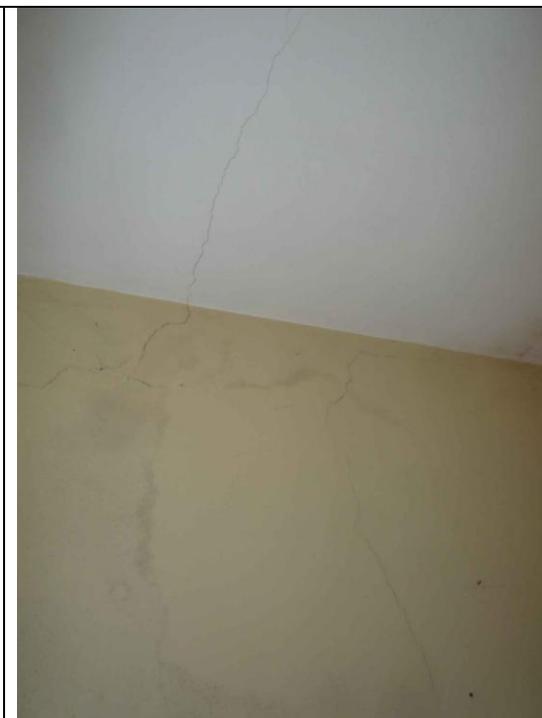
Fig.79: Cracking of plaster to chimney breast.

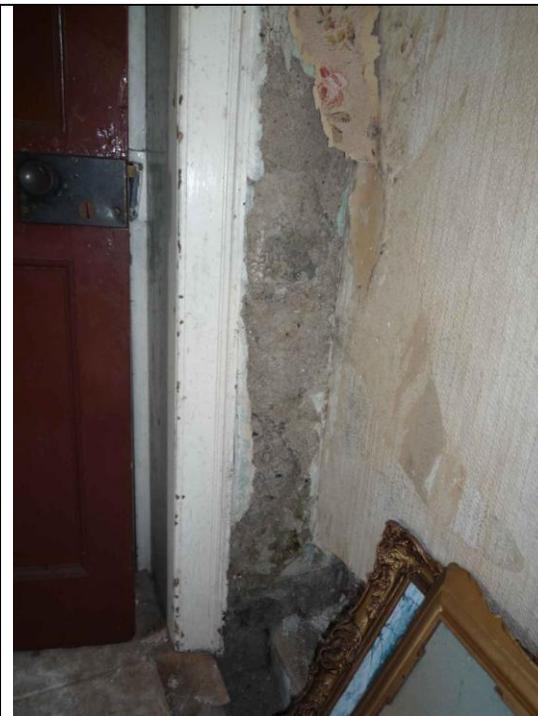
Fig.81: Plaster failure at junction of south and west walls.

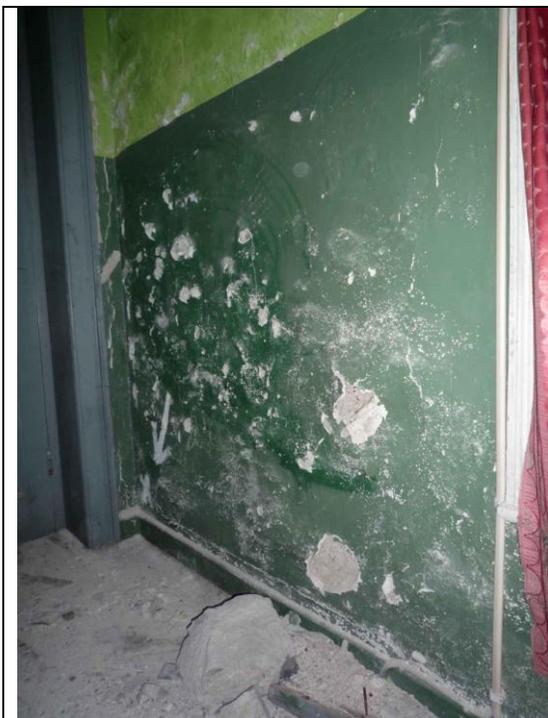
Fig.82: Failure of plaster to the west wall.

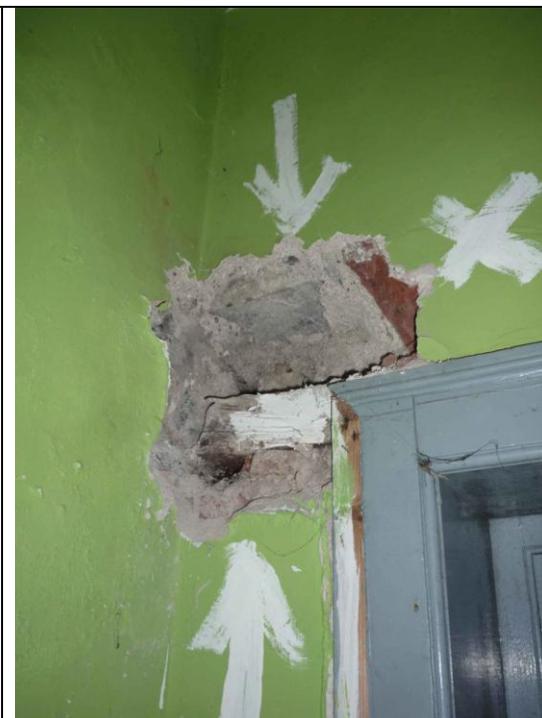
Fig.83: Previous opening-up works to the north wall to facilitate investigation of the timber lintel.

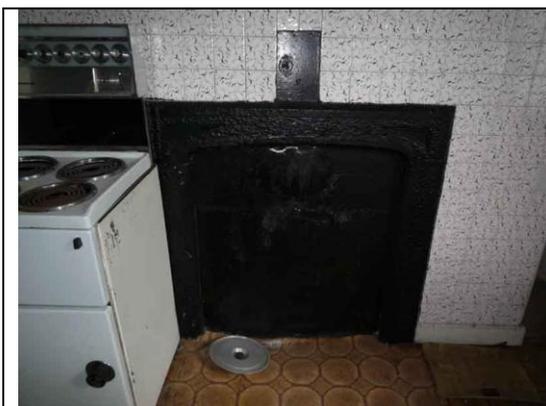
Fig.84: Over-painted stone fireplace with blocked opening.

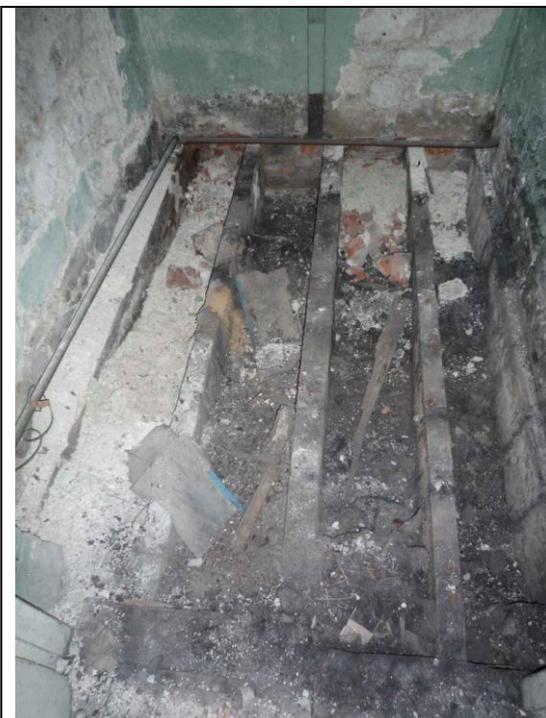
Fig.86: Missing timber floorboards - note the detritus between joists.

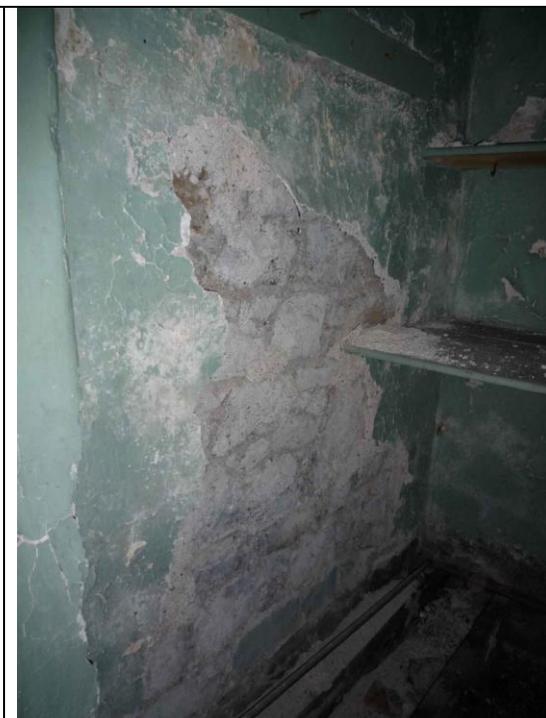
Fig.87: Plaster failure to the west wall.

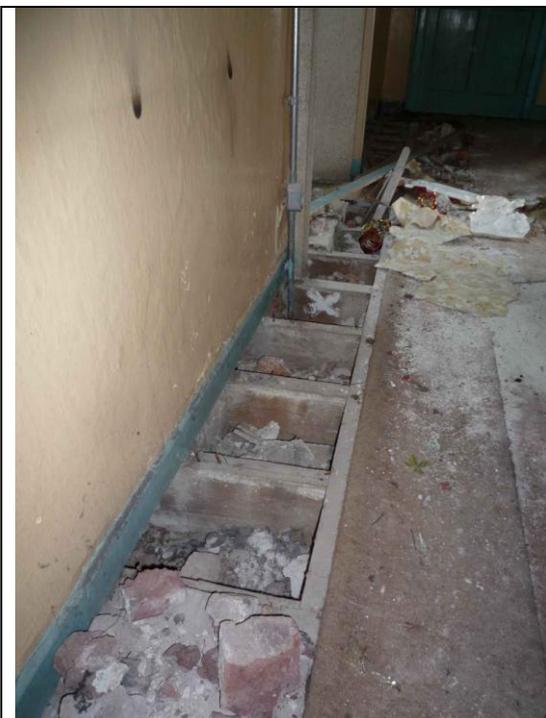
Fig.89: Missing timber floorboards to the north wall.

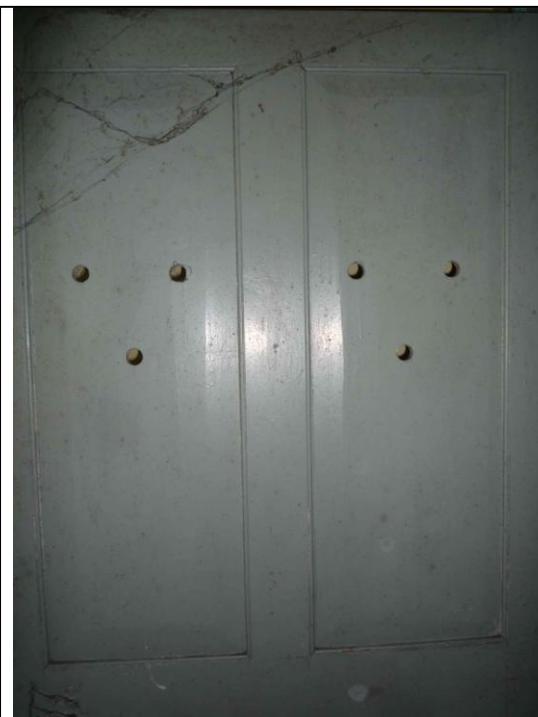
Fig.92: Vent holes to the upper panels of door.

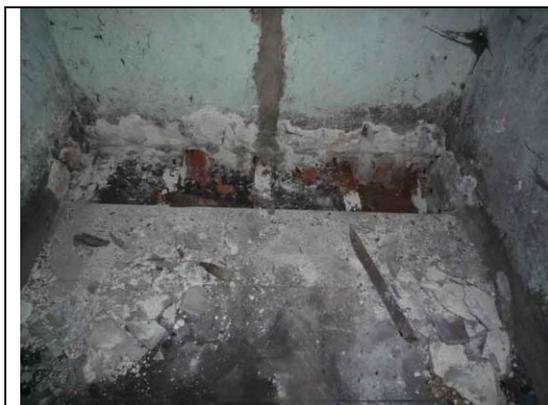
Fig.93: Missing floorboards to the north wall.

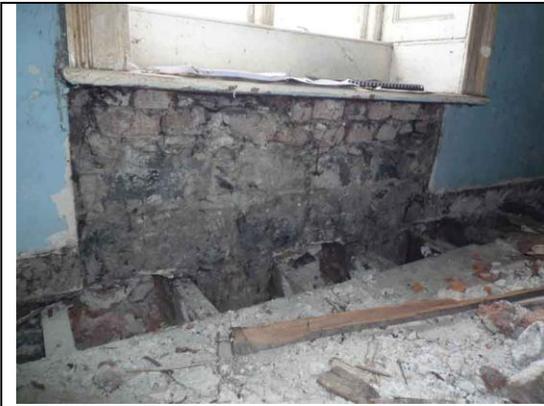
Fig.95: Missing timber window apron.

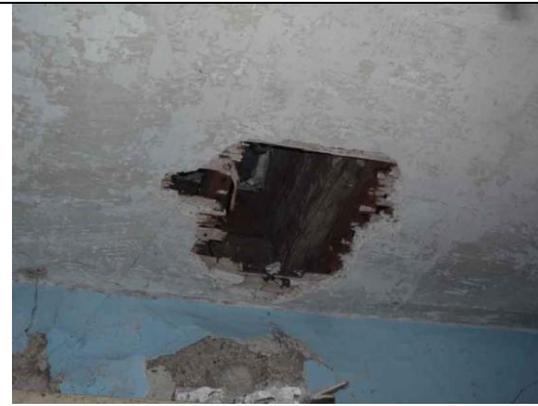
Fig.96: Hole to ceiling.

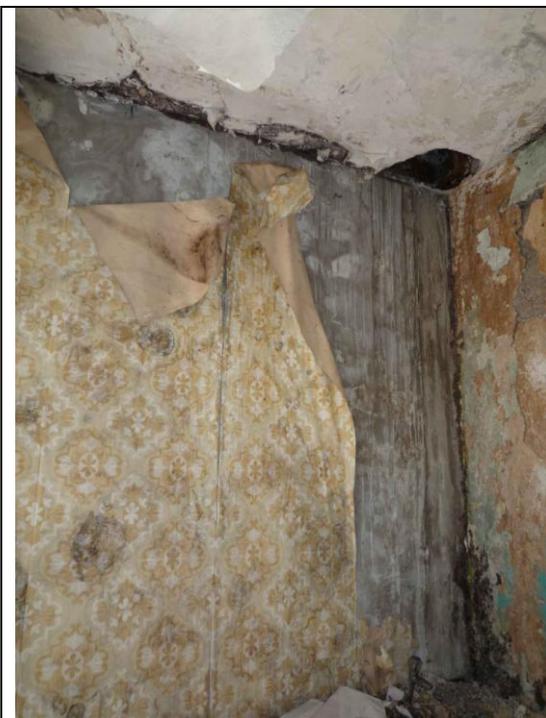
Fig.97: Failed wallpaper indicating dampness.

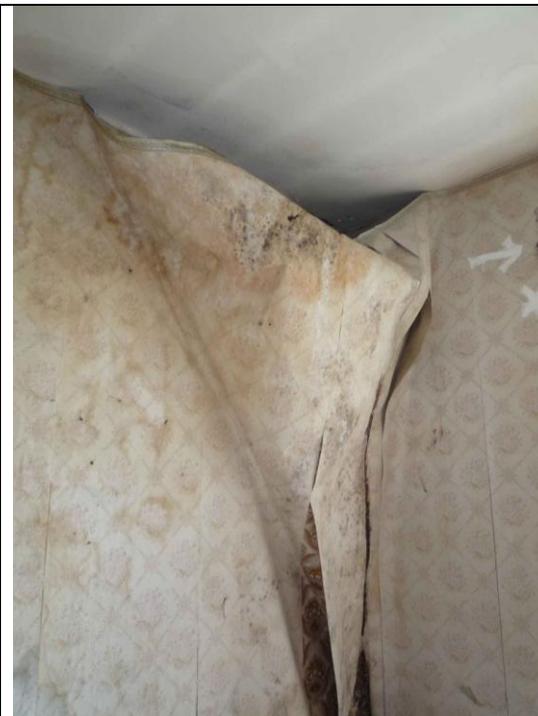
Fig.100: Failed wallpaper indicating dampness.

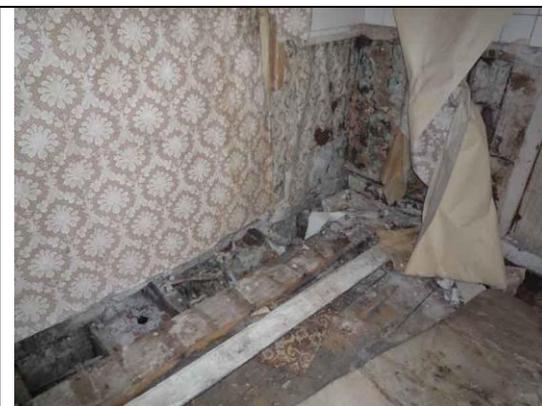
Fig.101: Missing timber floorboards to the east wall.

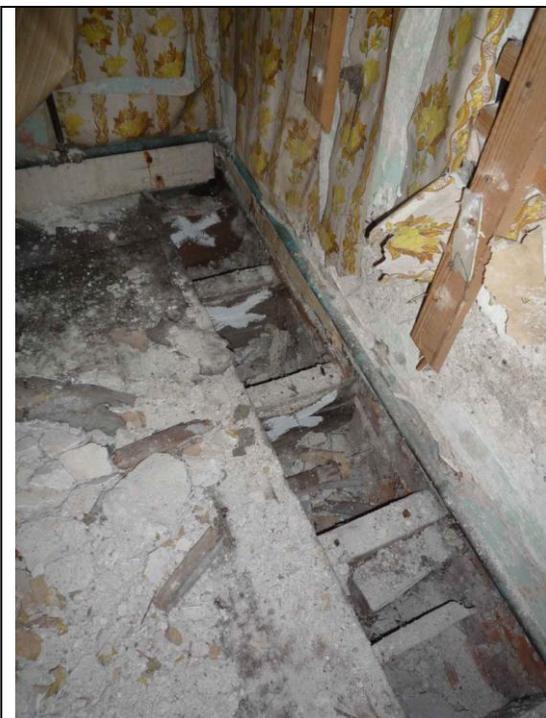
Fig.103: Missing floorboards to west wall.
