I wish to acknowledge receipt of your recent letter to Fáilte Ireland in relation to Environmental Impact Statement for the Proposed Pedestrian Bridge, Kilkenny City.

**PROPOSED PEDESTRIAN BRIDGE AT KILKENNY CITY  
YOUR REF EO877**

PROPOSED PEDESTRIAN BRIDGE,  
 KILKENNY CITY,  
 CO. KILKENNY

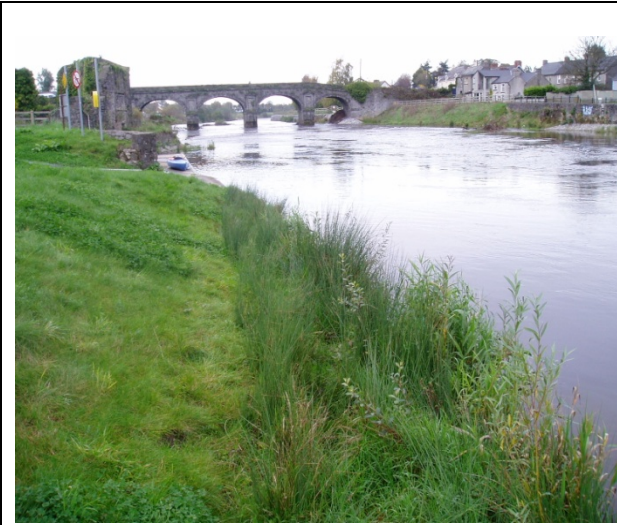
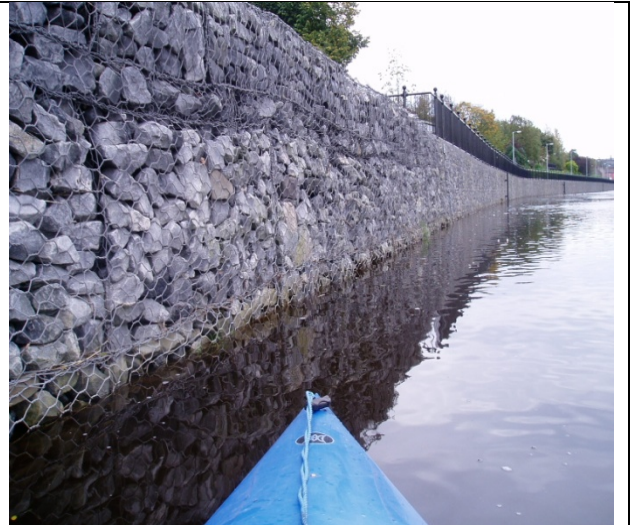
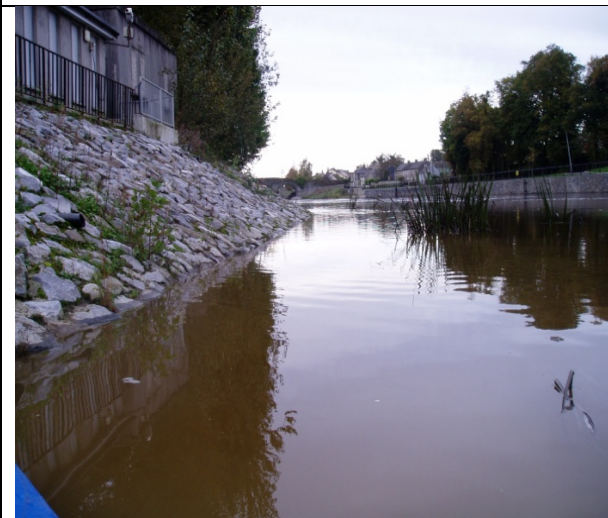
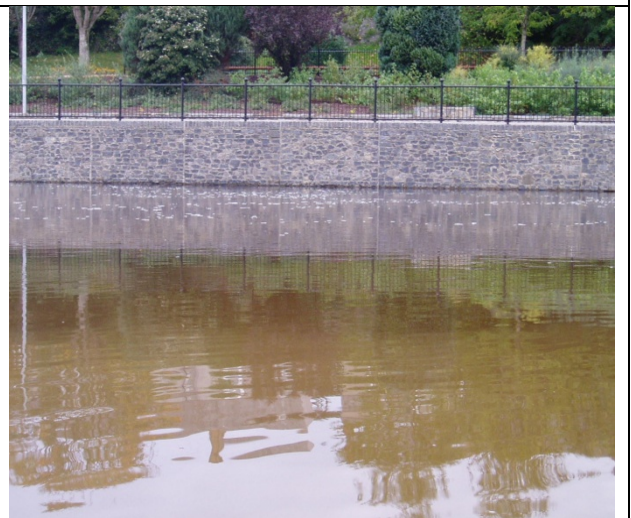
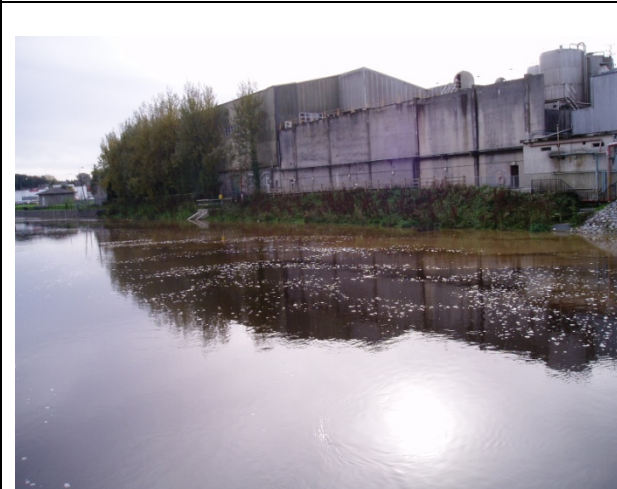
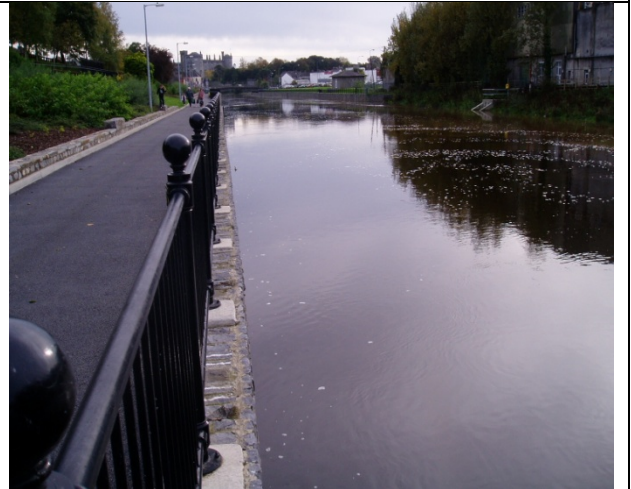
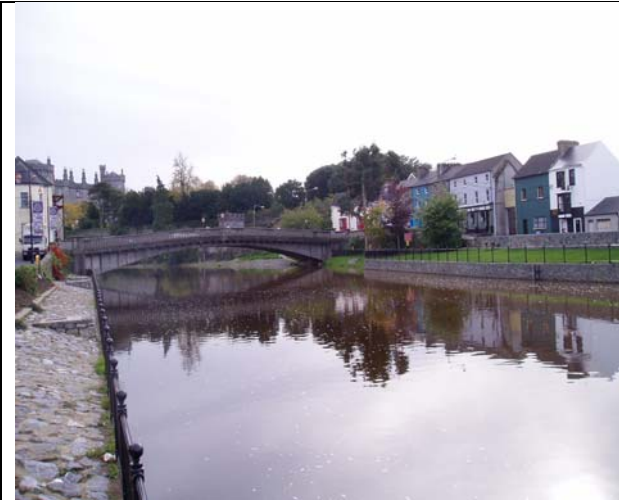
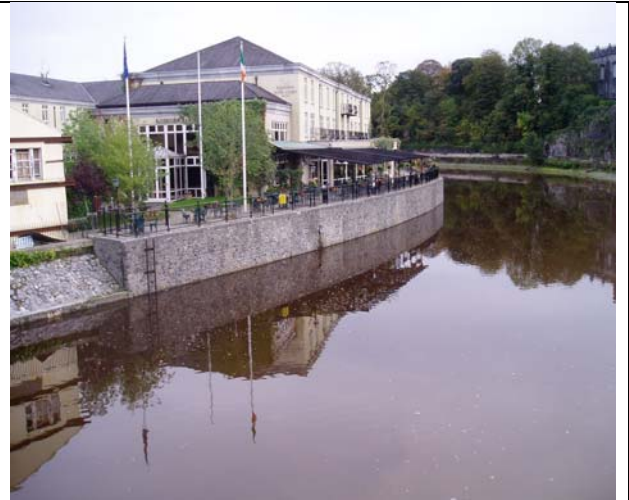
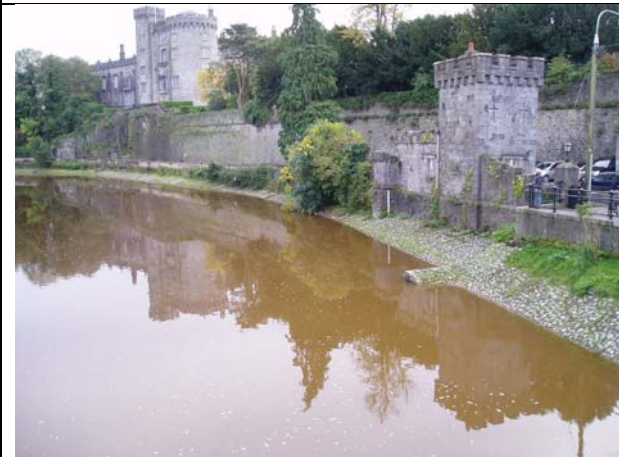
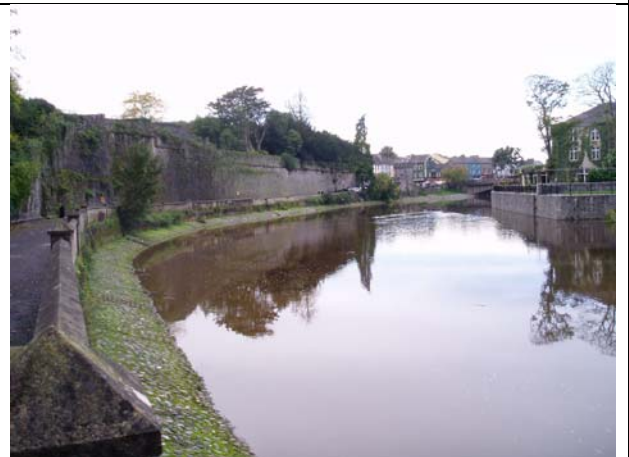
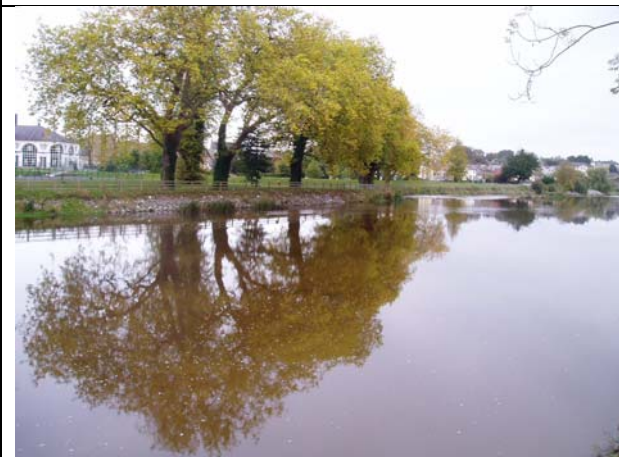
**Plate 1** - Habitat Section N(i) Nore Main Channel

**Plate 2** - Habitat Section N(i) Nore Main Channel

**Plate 3** - Habitat Section N(i) Nore Main Channel

**Plate 4** - Habitat Section N(i) Nore Main Channel

**Plate 5** - Habitat Section N(i) Nore Main Channel

**Plate 6** - Habitat Section N(i) Nore Main Channel

**Plate 7** - Habitat Section N(i) Nore Main Channel

**Plate 8** - Habitat Section N(i) Nore Main Channel

**Plate 9** - Habitat Section N(i) Nore Main Channel

**Plate 10** - Habitat Section N(i) Nore Main Channel

**Plate 11** - Habitat Section N(i) Nore Main Channel

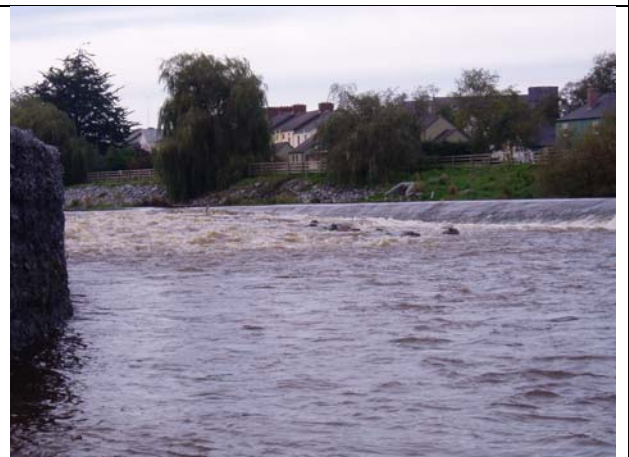
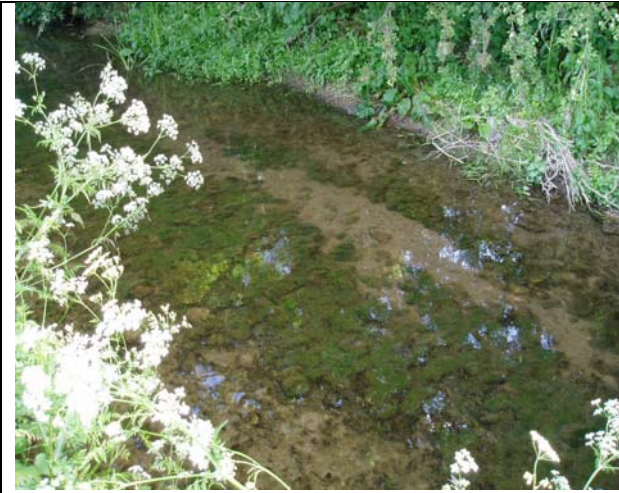
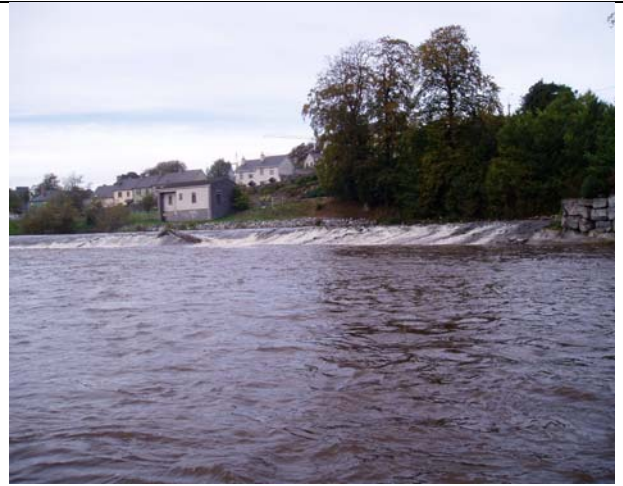
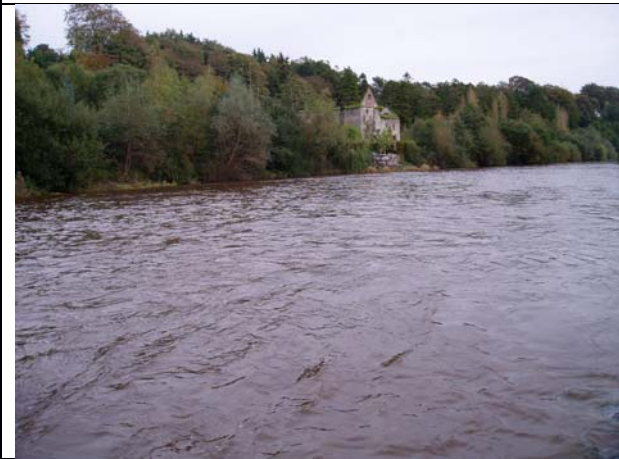
**Plate 12** - Habitat Section N(ii) Nore Main Channel

**Plate 13** - Habitat Section N(ii) Nore Main Channel

**Plate 14** - Habitat Section N(ii) Nore Main Channel

**Plate 15** - Habitat Section N(ii) Nore Main Channel

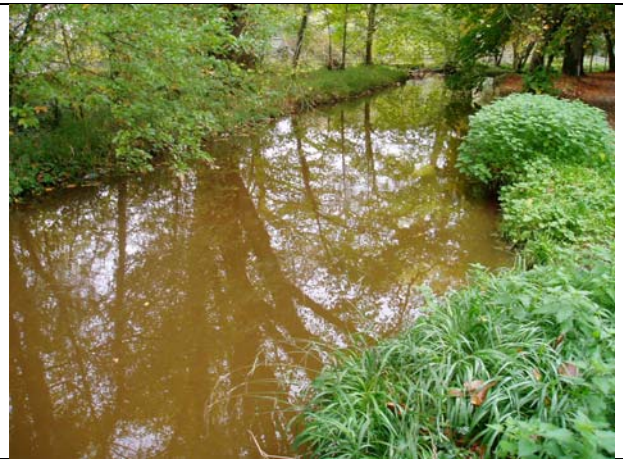
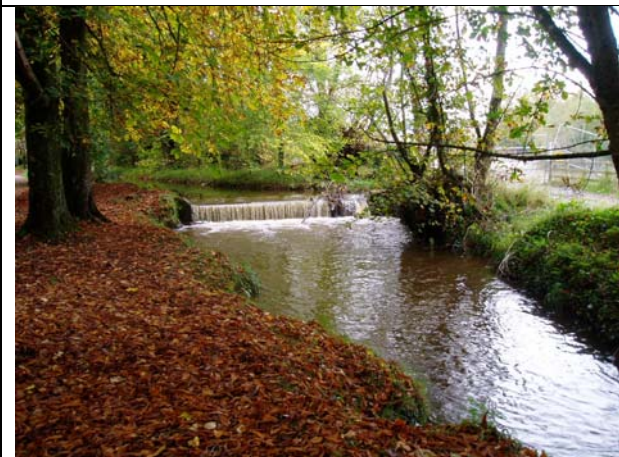
**Plate 16** - Habitat Section N(iii) Mill Race

**Plate 17** - Habitat Section N(iii) Mill Race

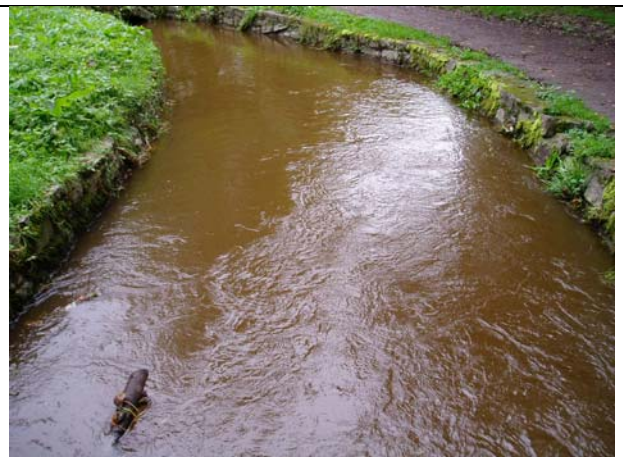
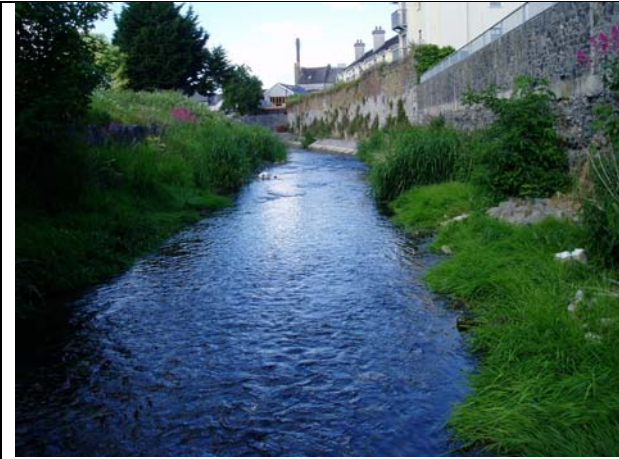
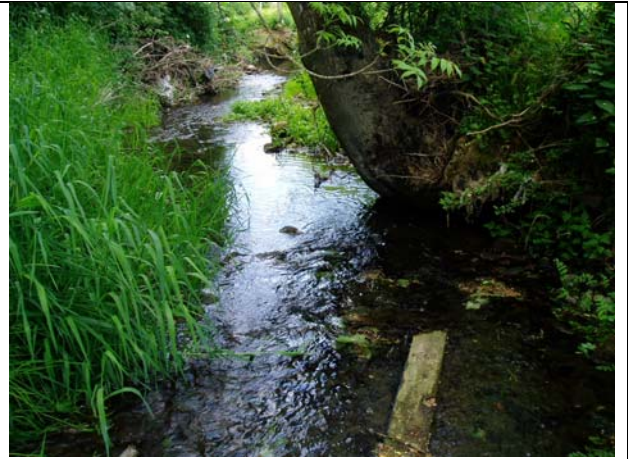
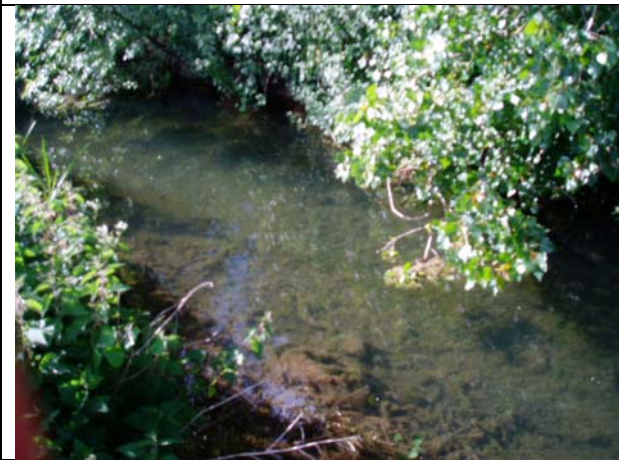
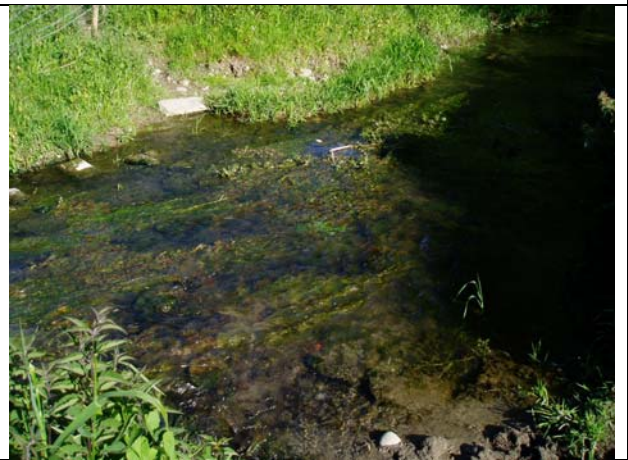
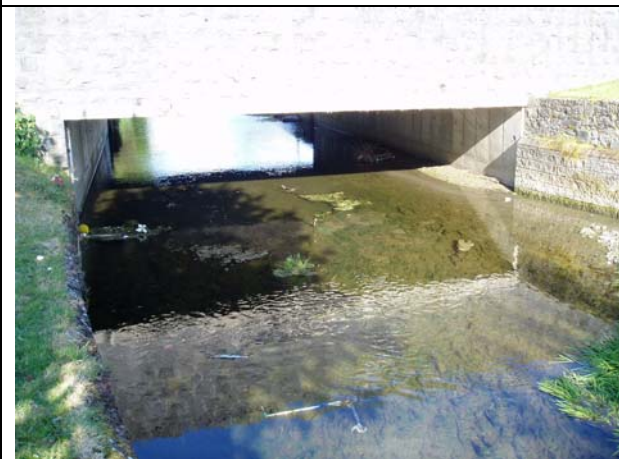
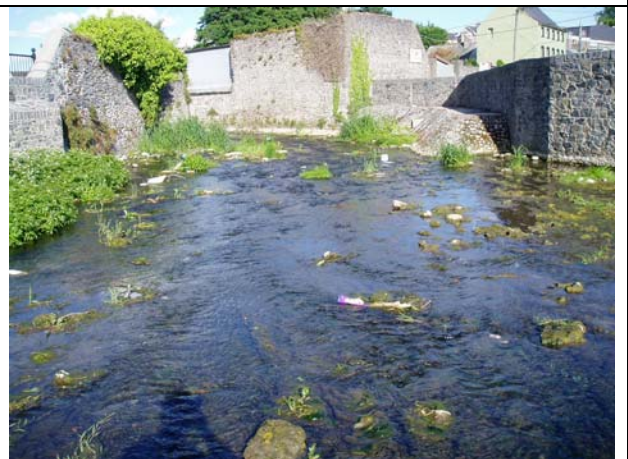
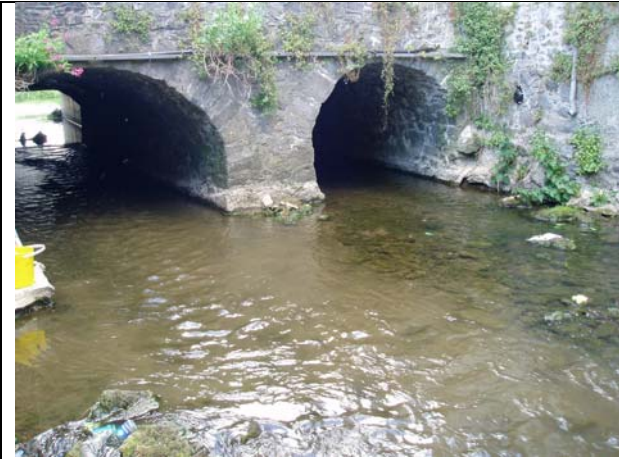
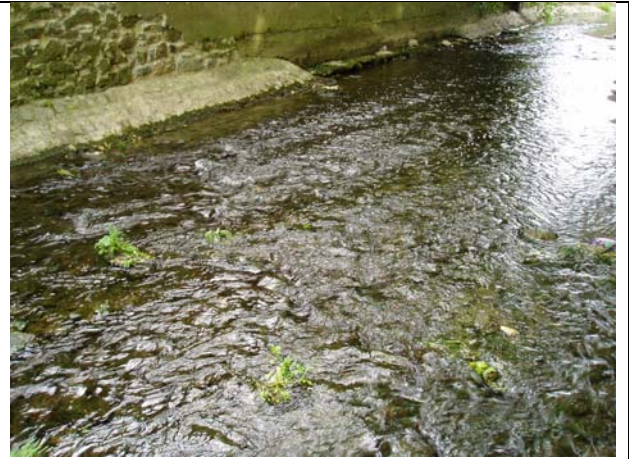
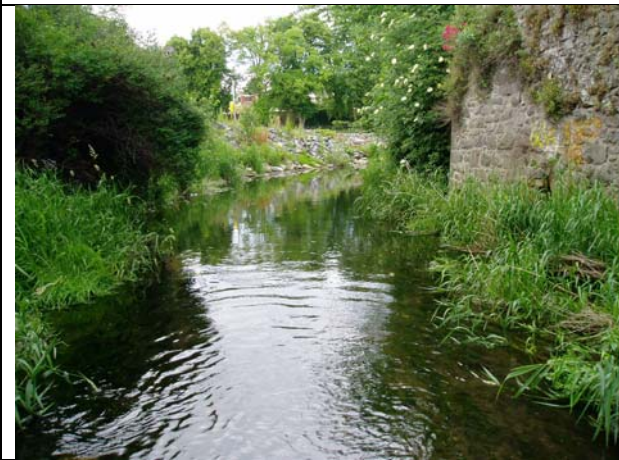
**Plate 18** - Habitat Section B (i) Breagagh River

**Plate 19** - Habitat Section B (i) Breagagh River

**Plate 20** - Habitat Section B (ii) Breagagh River

**Plate 21** - Habitat Section B (ii) Breagagh River

**Plate 22** - Habitat Section B (ii) Breagagh River

**Plate 23** - Habitat Section B (iii) Breagagh River

**Plate 24** - Habitat Section B (iii) Breagagh River

**Plate 25** - Habitat Section B (iii) Breagagh River

**Plate 26** - Habitat Section B (iii) Breagagh River

**Plate 27** - Habitat Section B (iii) Breagagh River

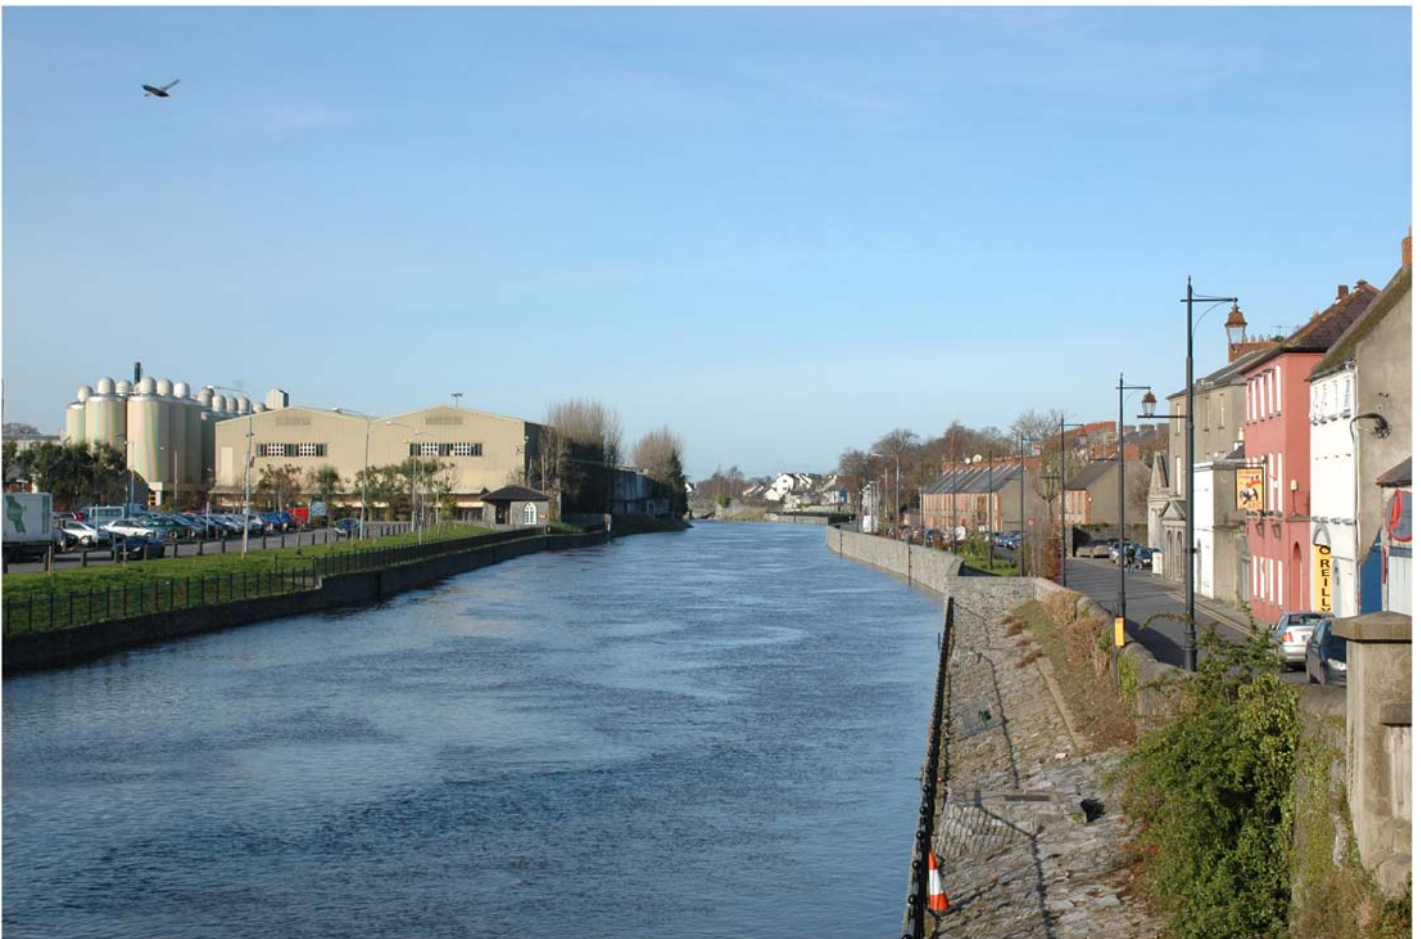
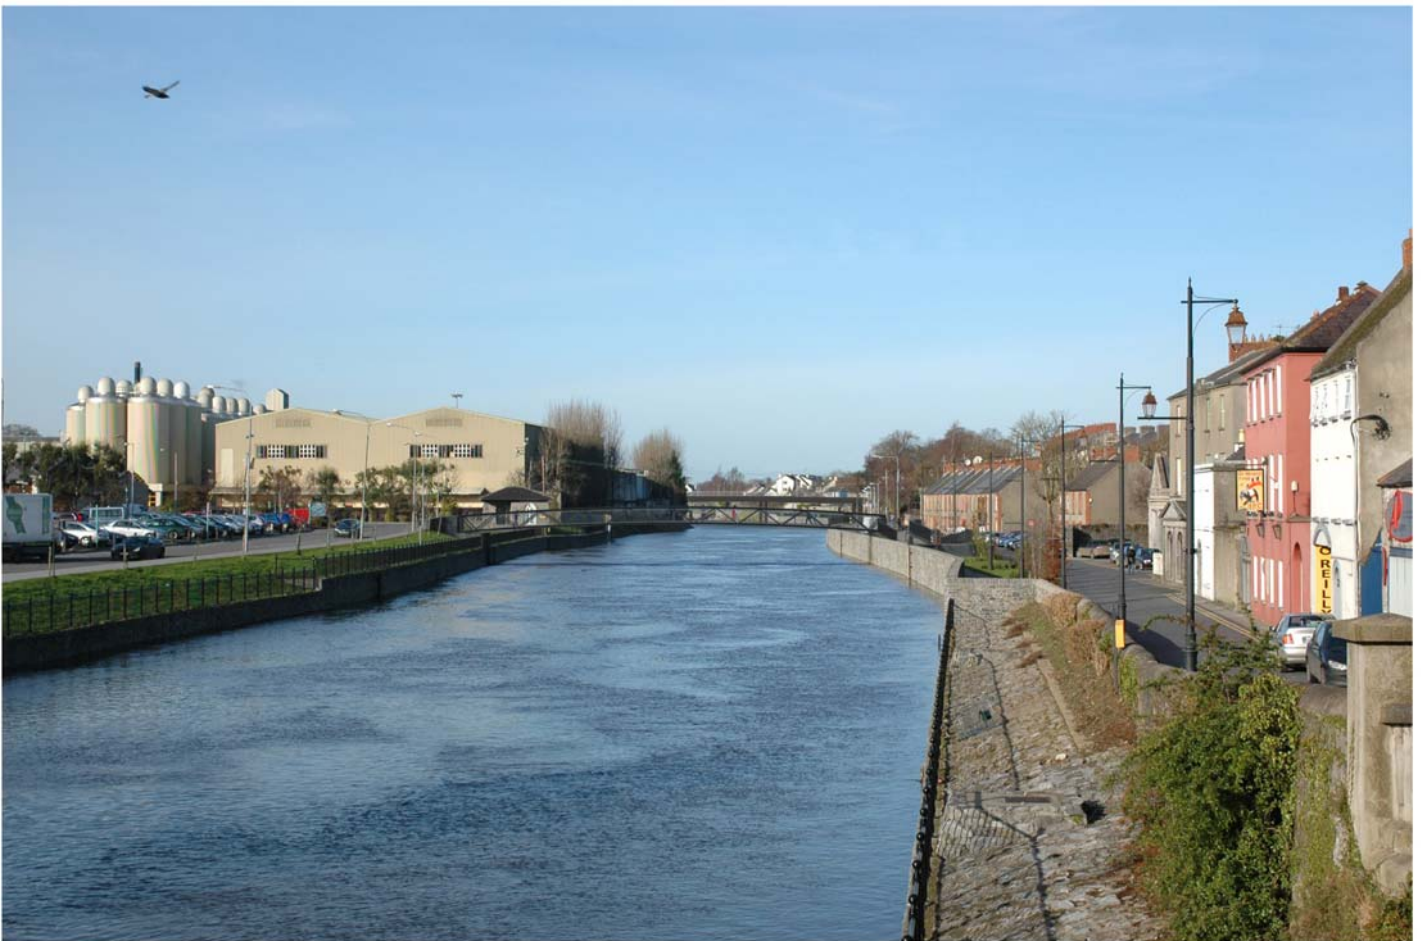
## Photomontage 1

Existing view

Proposed view

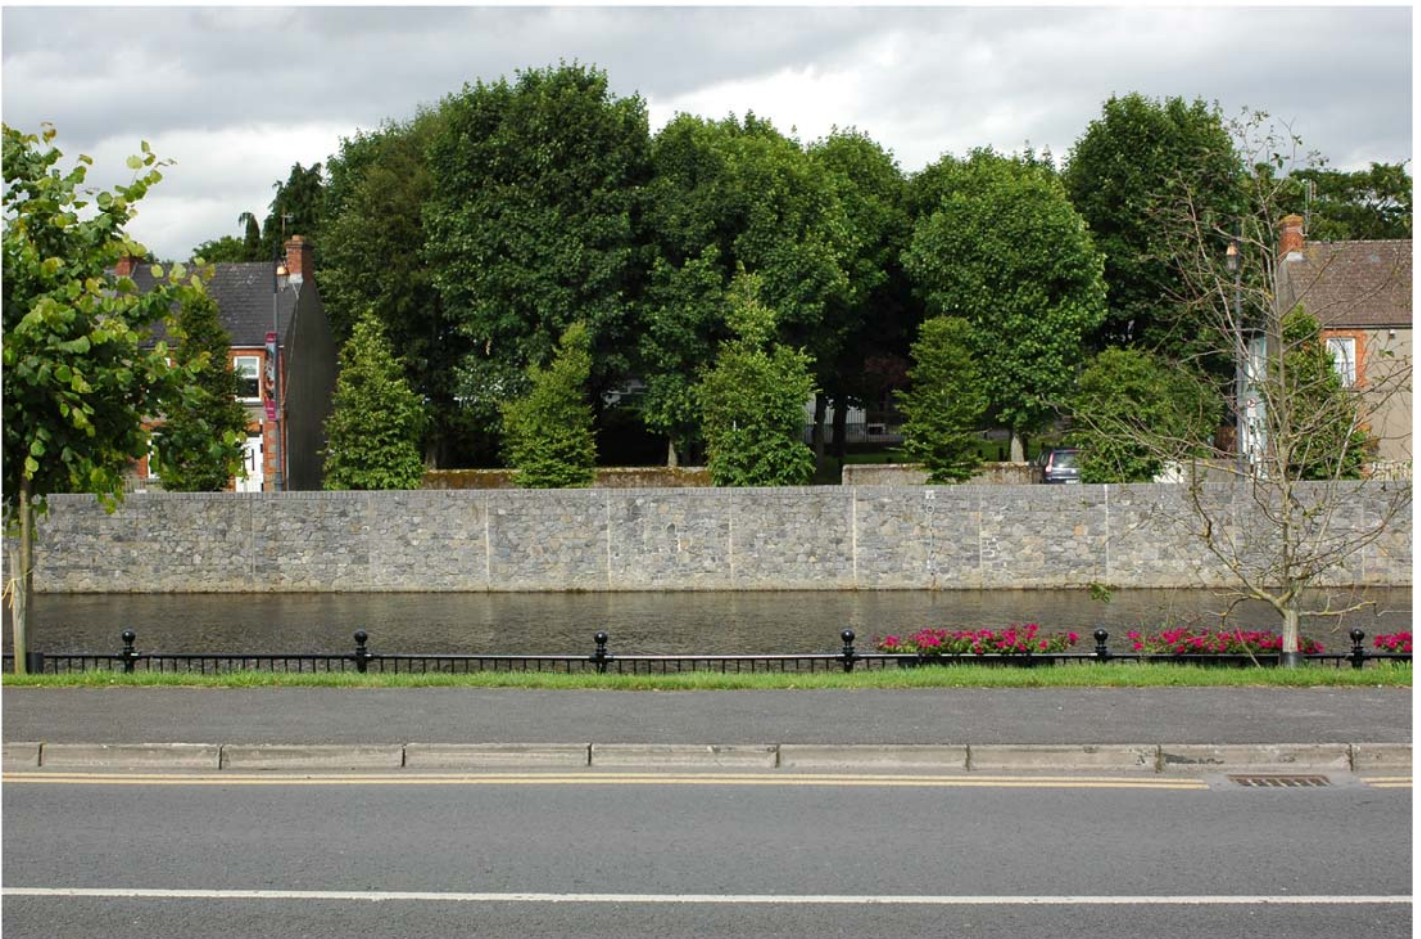
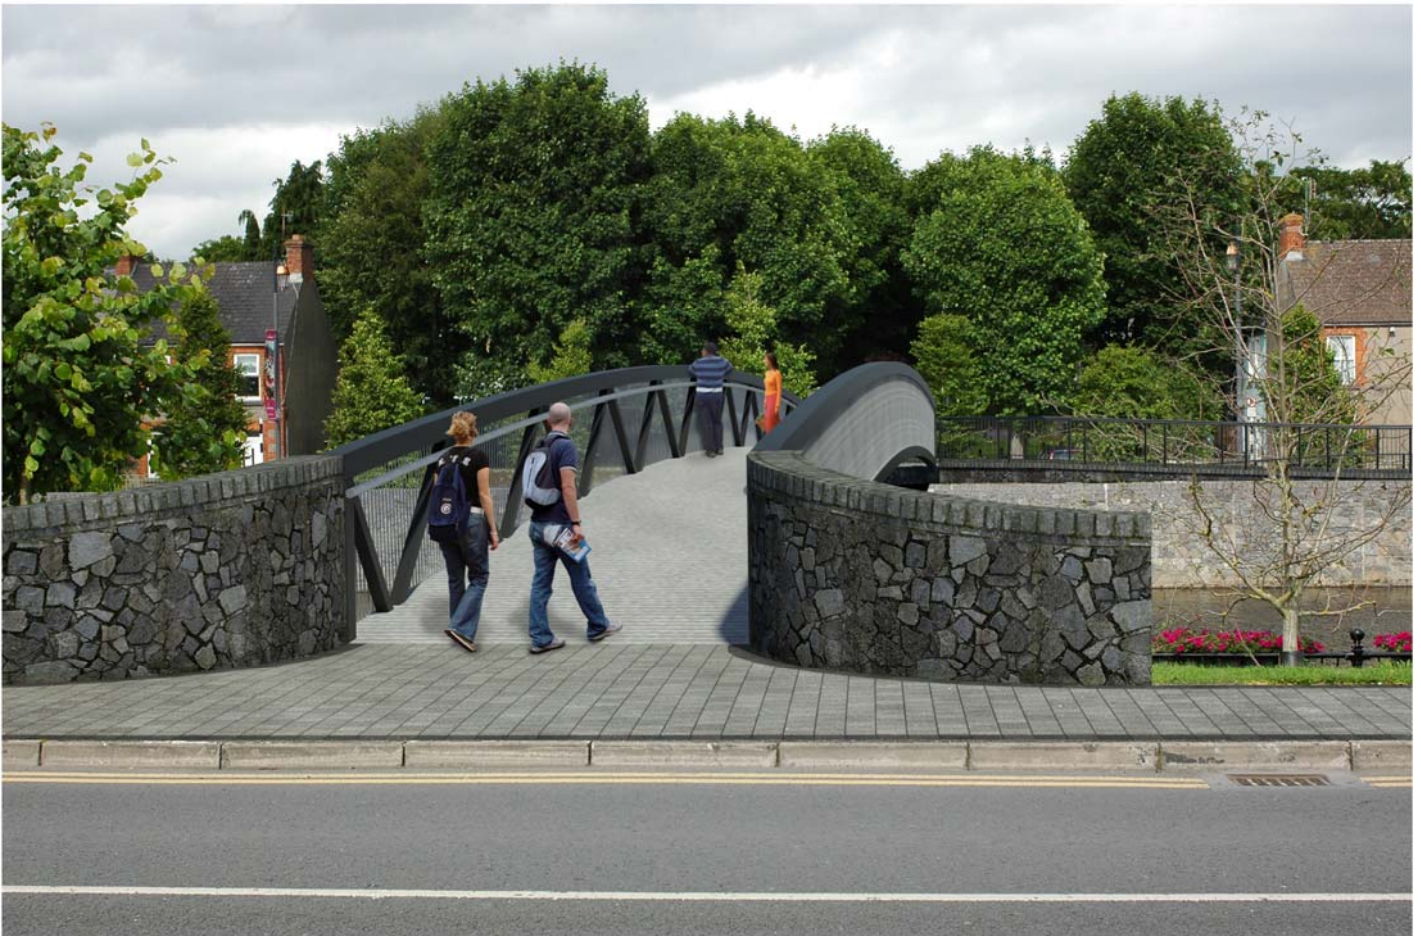
## Photomontage 2

Existing view

Proposed view

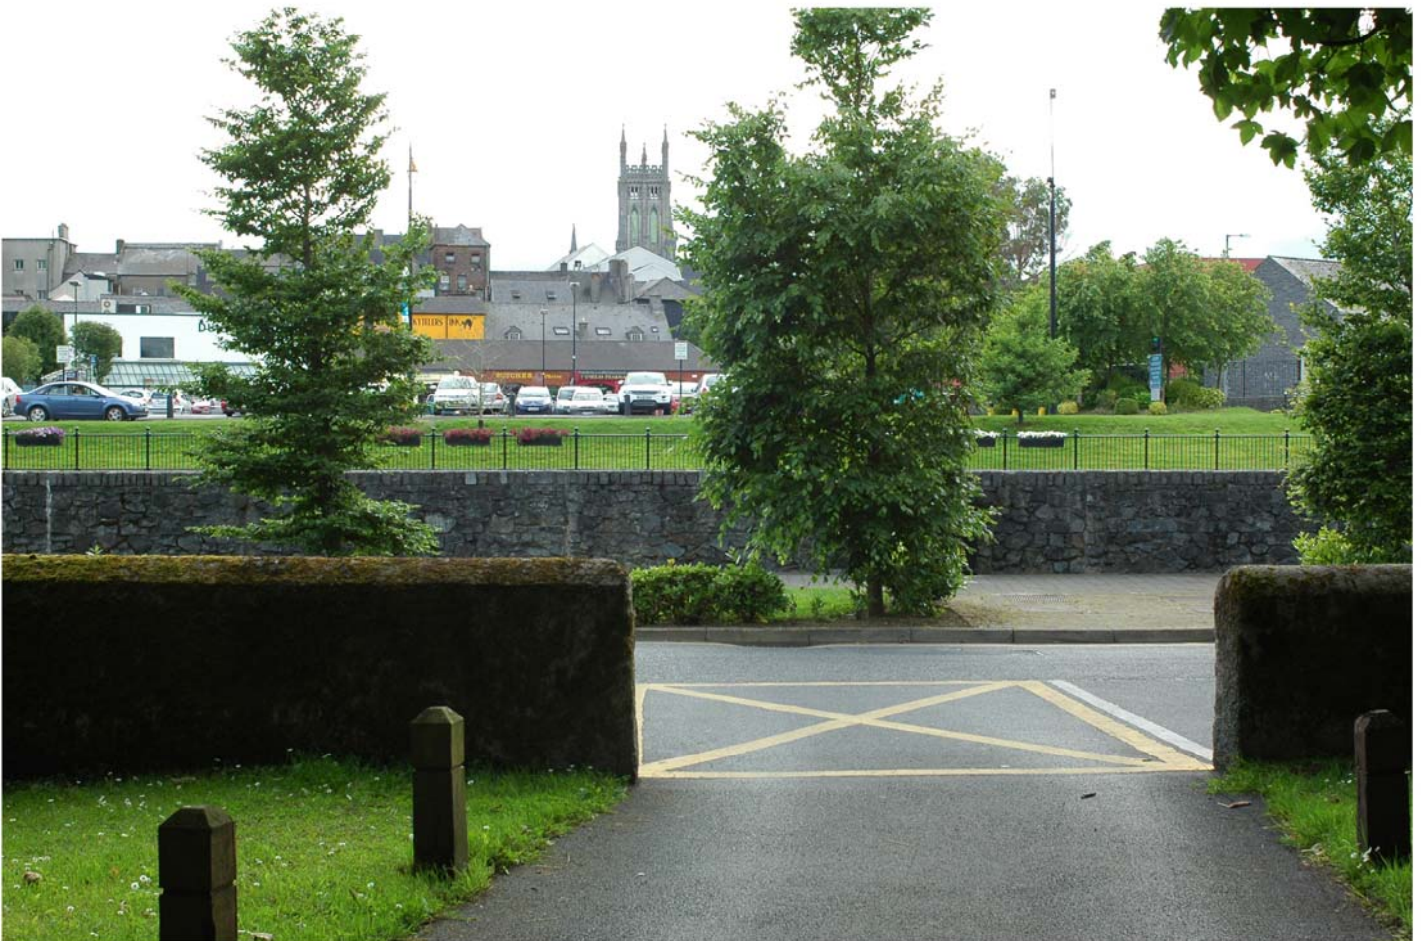
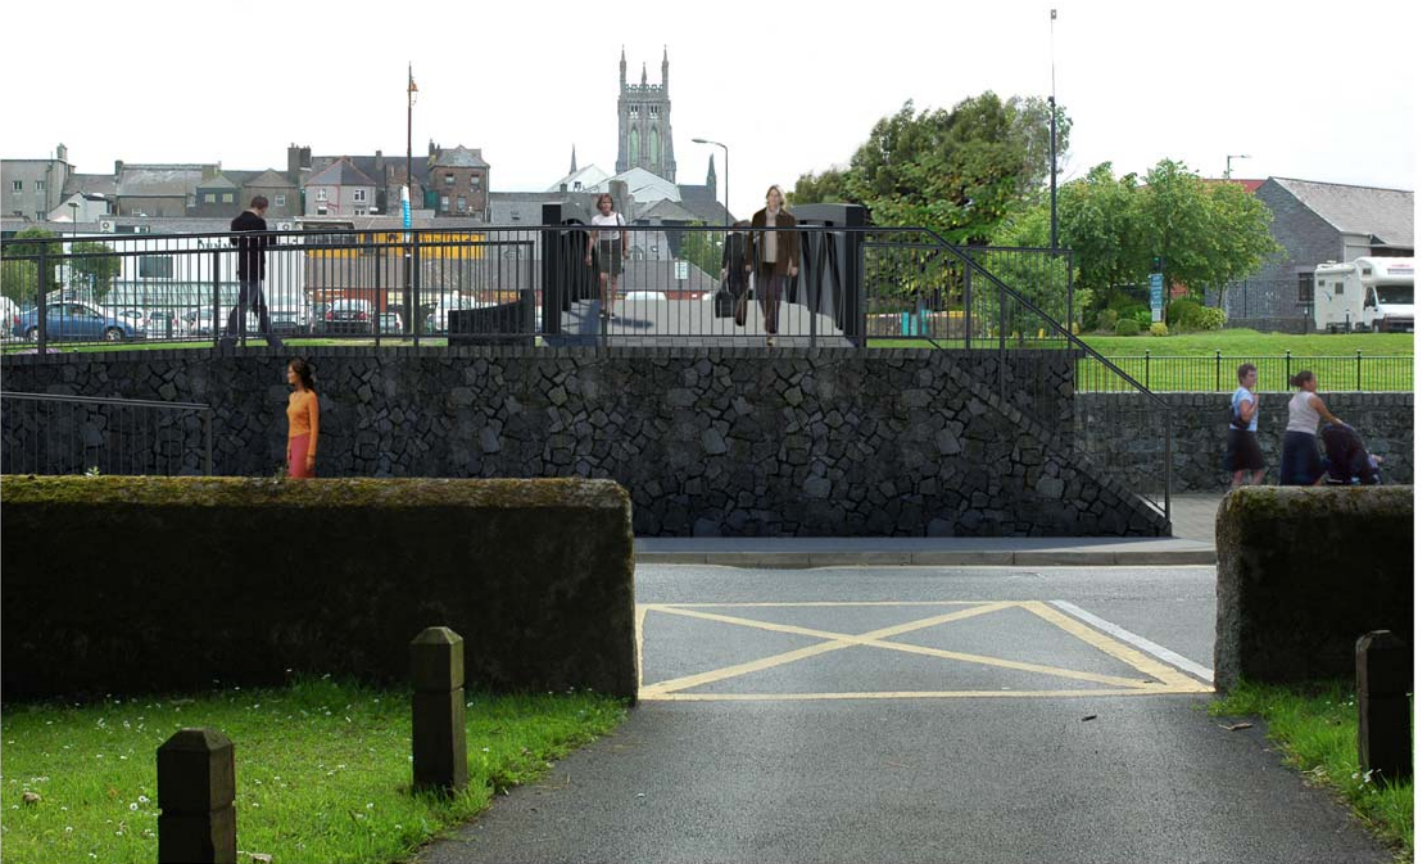
### Photomontage 3

Existing view

Proposed view

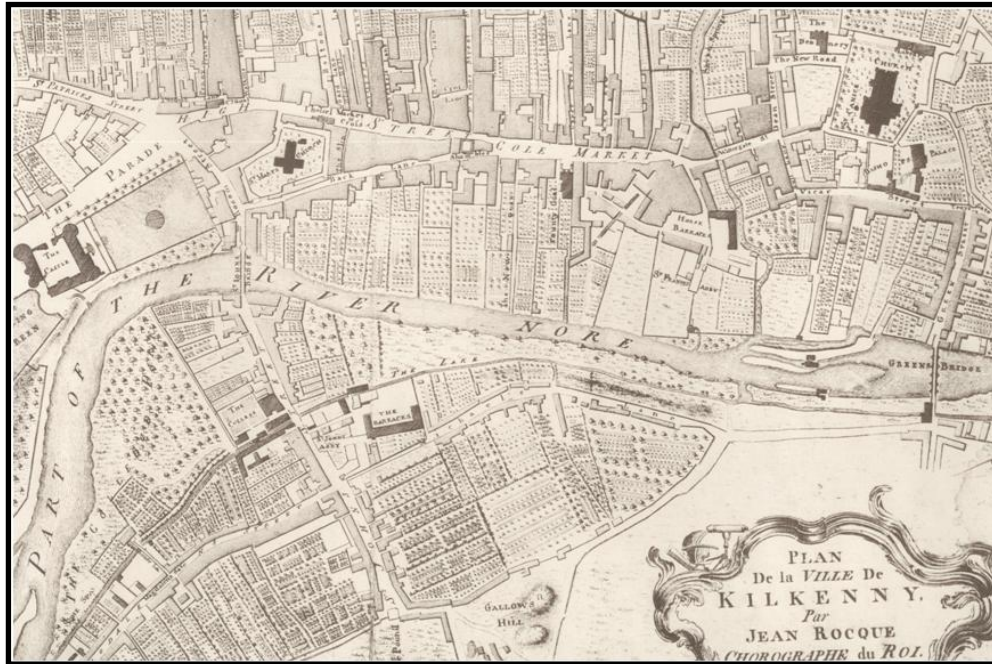
Figure 1: Detail of Rocque's map of Kilkenny, 1758

John Rocque's plan of Kilkenny, published in 1758, shows the city as it was in the mid-eighteenth century, with the land to the rear of buildings in what is now St. Kieran's Street extending all of the way back to the river. Similarly, on the eastern side of the Nore, Michael Street led through to Green's Bridge, but with no roads nearer to the water's edge other than a small lane leading off John Street Lower that met the river at right angles.

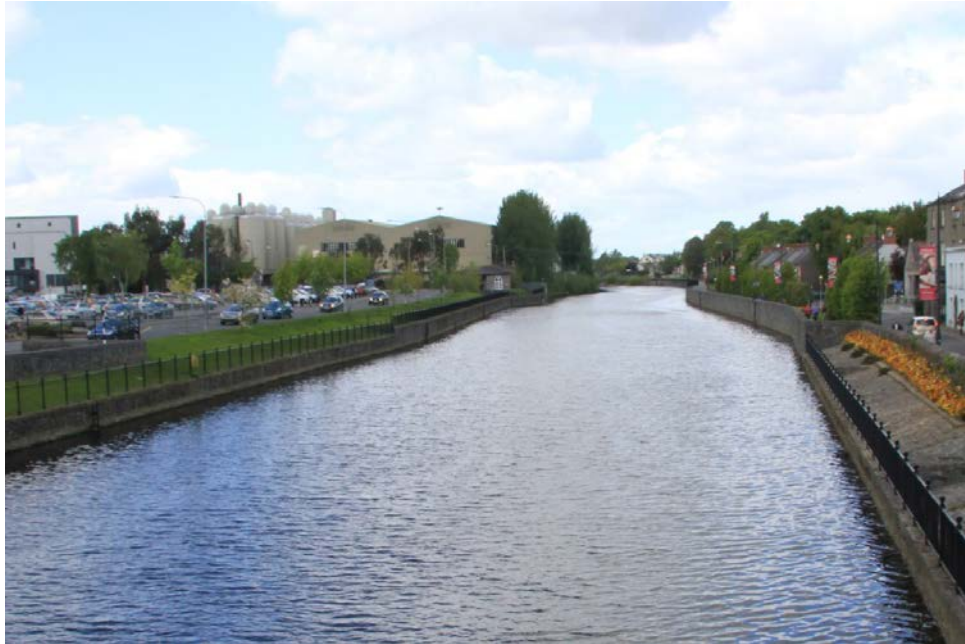
*Plate 1: View northwards to site of proposed bridge from John's Bridge*

At present there are two river crossings on the Nore in the city of Kilkenny. Green's Bridge and John's Bridge are more than 700 metres apart, with no intermediate link between the city centre and the eastern bank of the river.

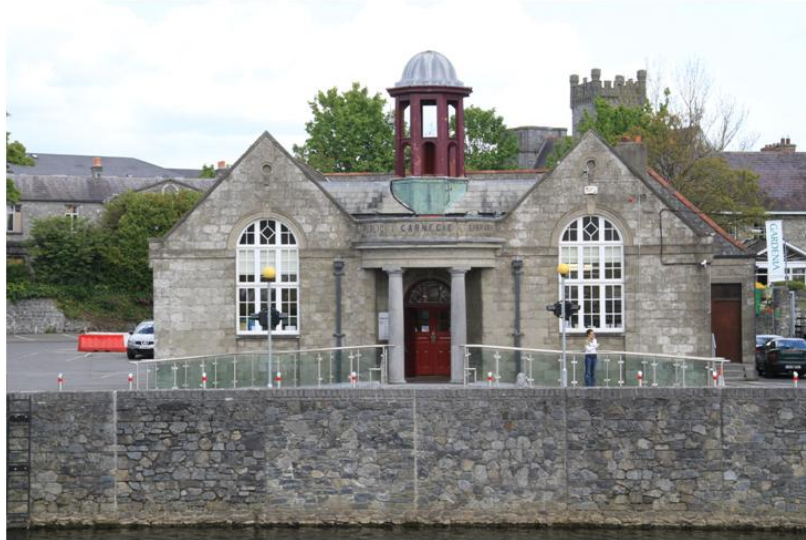
*Plate 2: Carnegie Library, John's Quay*

The Carnegie Library on John's Quay is the only protected structure in the immediate vicinity of the proposed bridge. It is a single-storey building with two gables to the front, separated by a projecting porch supported on Doric columns. The central feature is a cupola in the centre of the building.

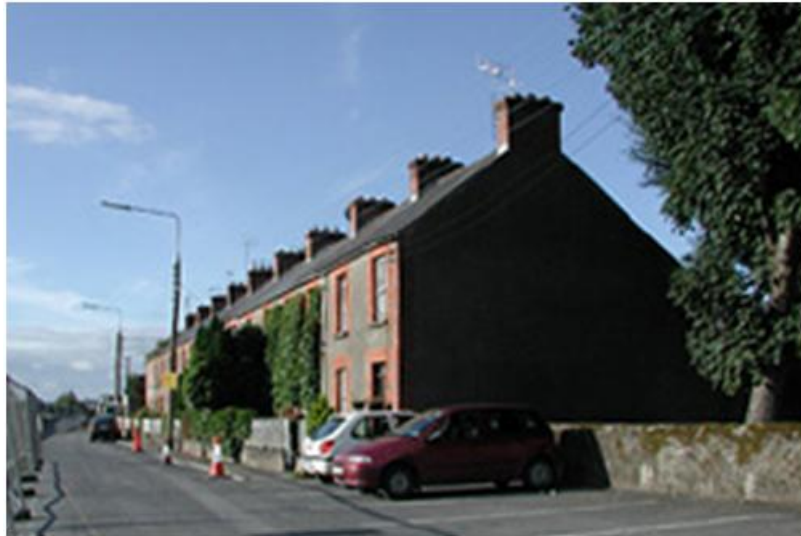
*Plate 3: Parnell Terrace*

Parnell Terrace consists of nine two-storey houses divided into one pair of semi-detached and a terrace of seven. They are gable-ended and are faced with roughcast render, with red brick detailing to the window and door opens.

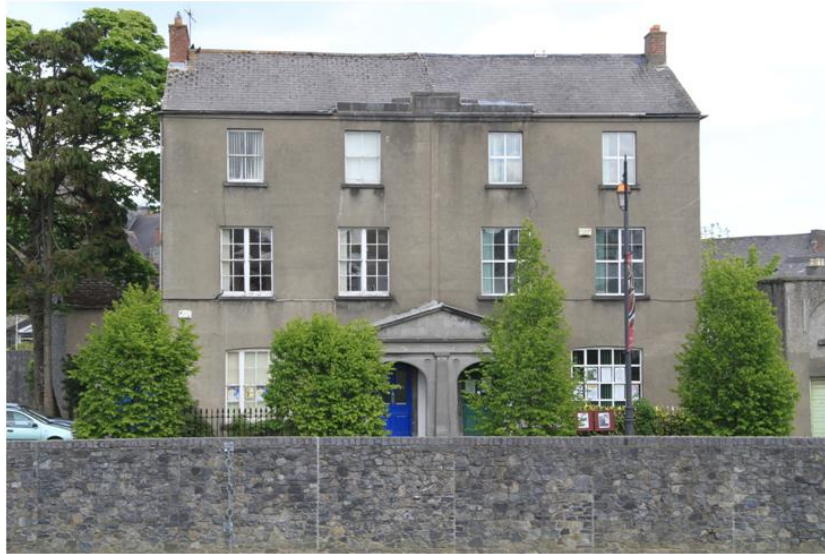
*Plate 4: 5 and 6 John's Quay*

The pair of semi-detached houses at 5 and 6 John's Quay are each two-bay and three-storey, with a gabled, slated roof. The houses have a pedimented double porch to the front.

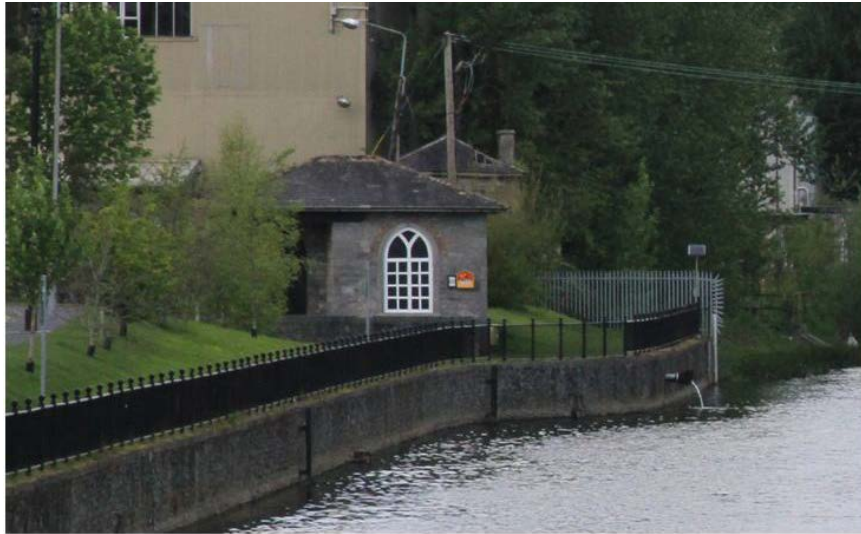
*Plate 5: Tea House, seen from the river*

On the river's edge at the rear of Smithwick's Brewery, and at the edge of the former markets there is a small single-storey tea room. Positioned at an angle to the river, the building appears to have been designed to make the best of the view down the river to Kilkenny Castle.

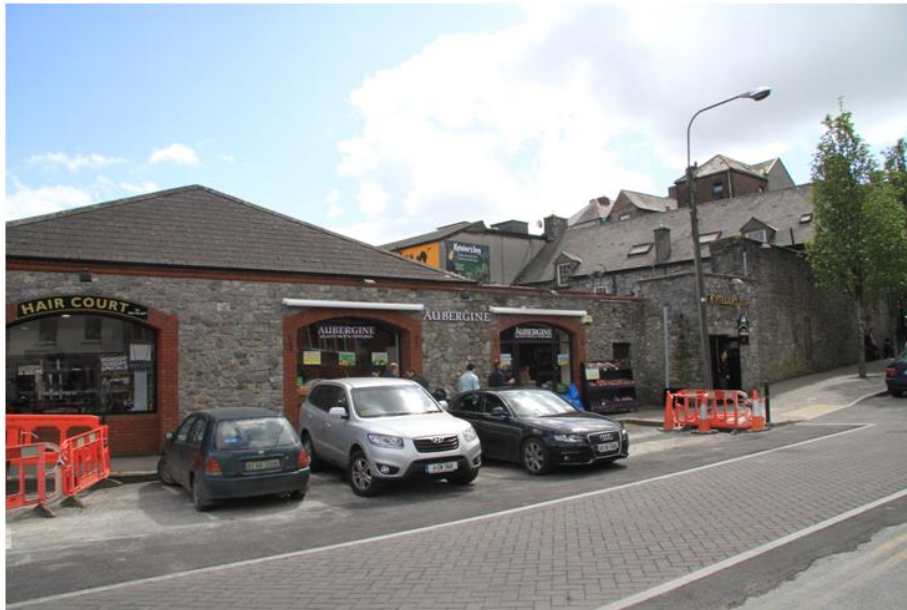
*Plate 6: Rear of Kyteler's Inn, facing towards river*

Kyteler's Inn, in St. Kieran's Street, is a building complex of significance, and includes building fabric from the late 13<sup>th</sup> century to the present day. It is at a significant distance from the site of the proposed bridge, and its rear faces the river, with a group of later buildings behind the original structure.

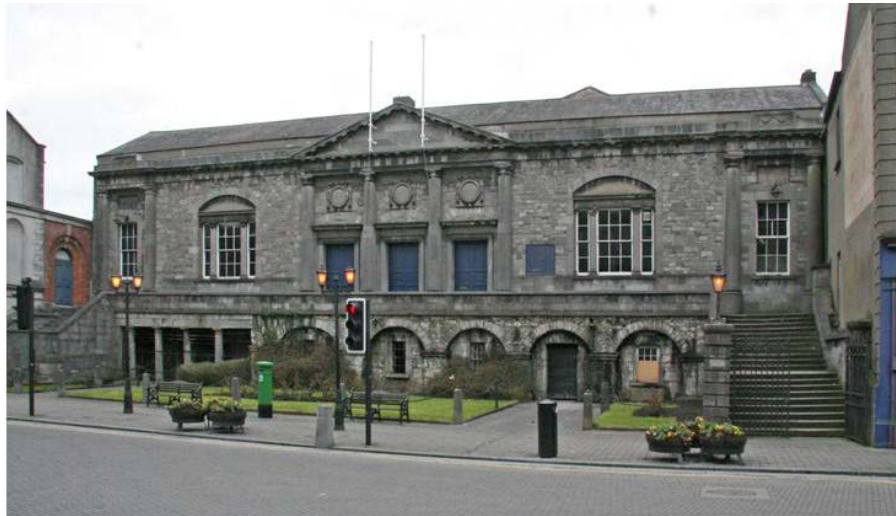
*Plate 7: Kilkenny Courthouse, Parliament Street*

On Parliament Street, but backing towards the river, the Kilkenny Courthouse is a late eighteenth century Neoclassical building of national significance.

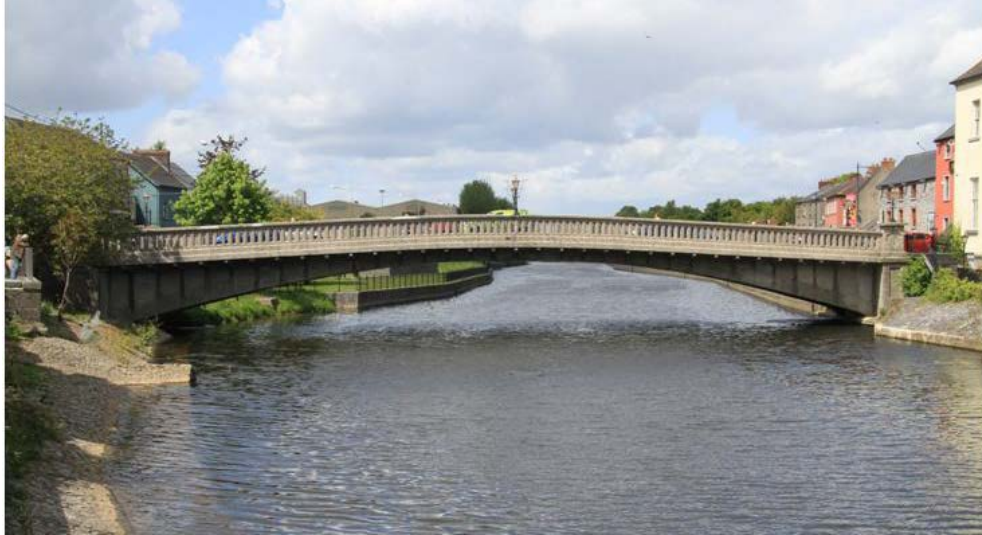
*Plate 8: John's Bridge, with site of proposed bridge visible through arch*

St. John's Bridge is on the site of a bridge that was destroyed in a flood in 1763, and adjacent to the site of the bridge that replaced it. The present bridge is an early example of a reinforced concrete bridge, and at the time of its construction had the greatest span of any such bridge in these islands.

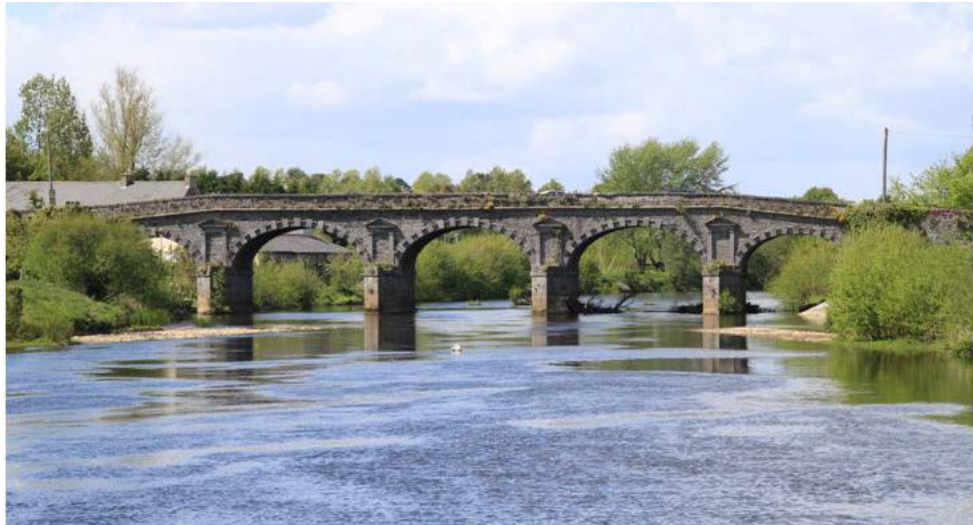
*Plate 9: Green’s Bridge*

Green’s Bridge was built in the 1760s to replace an earlier bridge that had been destroyed in a flood. It is one of several bridges on the Nore that were rebuilt at this time in a Palladian style, incorporating elements of classical architecture. The bridge has five arches in the river channel, each with a Gibbsian arch ring and with pedimented aedicules on the faces of the piers.

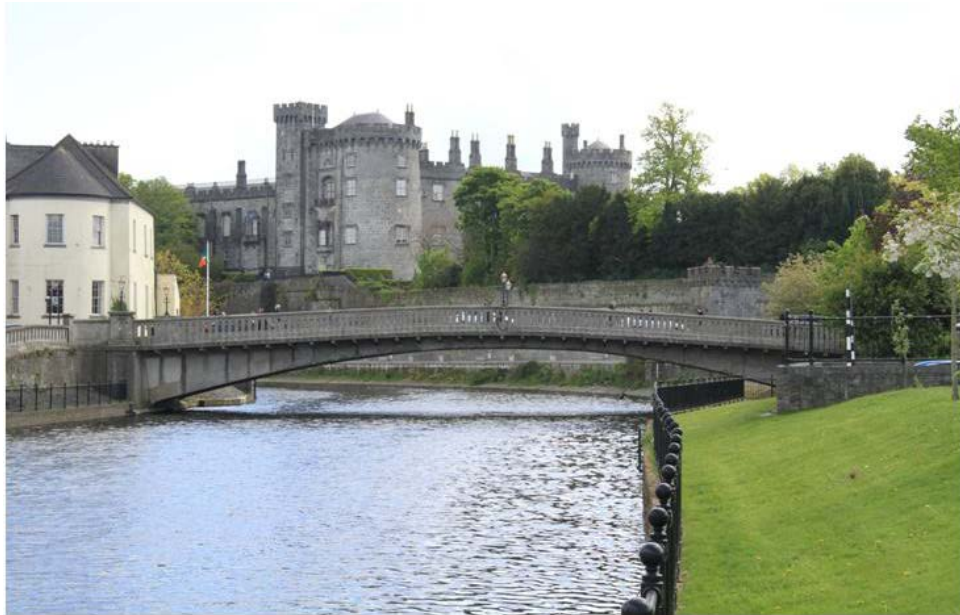
*Plate 10: Kilkenny Castle and John's Bridge*

Kilkenny Castle is a medieval castle with substantial amounts of reconstruction over the centuries, particularly in the 1820s. It stands on a height above the river in a commanding position and presents an imposing backdrop to the view from the proposed bridge past John's Bridge. The photograph above shows the view from the river bank. The proposed bridge would open new vistas, without adverse effect on the character of the castle.
