I wish to acknowledge receipt of your recent letter to Fáilte Ireland in relation to Environmental Impact Statement for the Proposed Pedestrian Bridge, Kilkenny City.

**PROPOSED PEDESTRIAN BRIDGE AT KILKENNY CITY  
YOUR REF EO877**

PROPOSED PEDESTRIAN BRIDGE,  
 KILKENNY CITY,  
 CO. KILKENNY

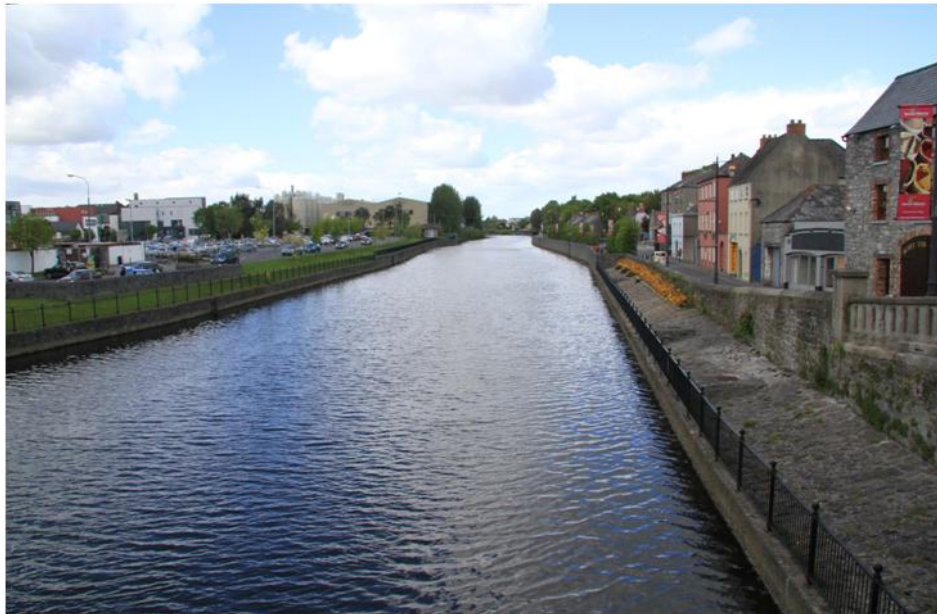
*Plate 11: View upriver from John's Bridge towards Green's Bridge*

John's Bridge is in the heart of the city and has a significant footfall of pedestrians, as well as substantial amounts of traffic. The view upriver from the bridge is significant, and includes a number of architectural features. For the most part the view of the buildings addressed in this report would not be affected by the proposed bridge. The possible exceptions are the Tea House and Green's Bridge.

**Tea House:** The view of the Tea House from John's Bridge is not significant, and any potential interruption of the view would not be perceptible.

**Green's Bridge:** Only the easternmost end of Green's Bridge may be seen from John's Bridge, and it is not an obvious feature in the view. Any potential interruption to the view would not be significant.

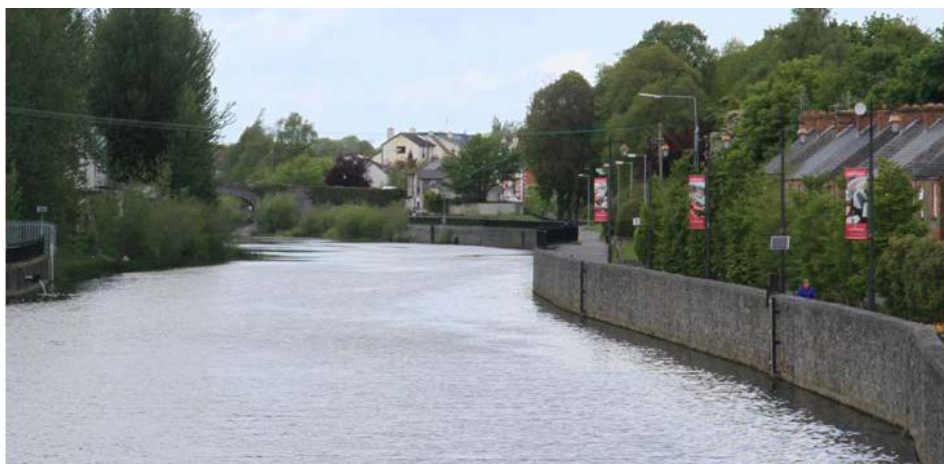
*Plate 12: View of Green's Bridge from John's Bridge, photographed using a long lens*

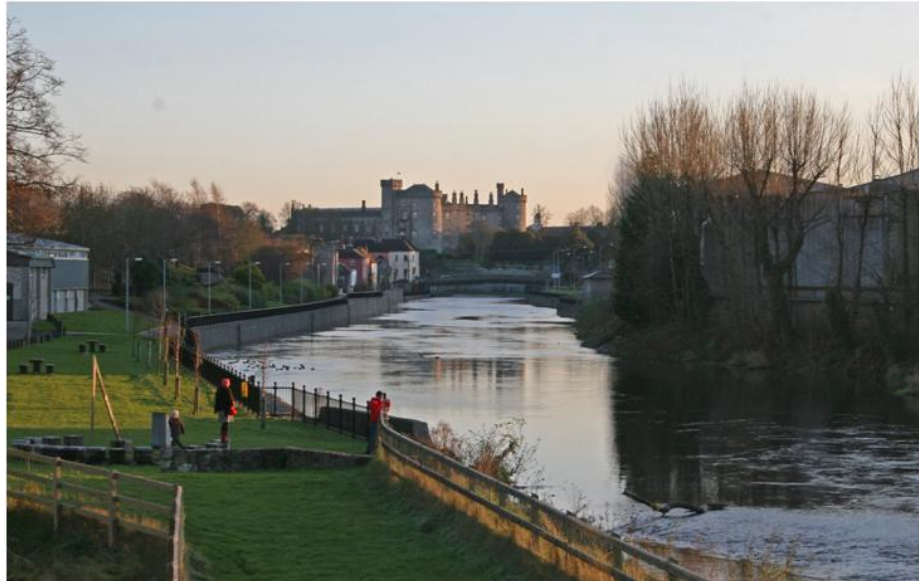
*Plate 13: View of Kilkenny Castle from eastern end of Green's Bridge*

The view from the centre of Green's Bridge down the river does not take in any features of architectural significance. From the eastern end of the bridge there is a view that includes Kilkenny Castle on the skyline, with John's Bridge visible, but not prominent in the view. The photograph above was taken in winter when there was minimal interruption of the view caused by leaves on the trees. There is significantly less footfall over Green's Bridge than over John's Bridge, it being at a greater distance from the city centre.
