**PROPOSED NEW BUTLER GALLERY AT
EVAN'S ALMS HOUSE,
BARRACK LANE, KILKENNY**

**VOLUME 2: ADDENDUM
INTERNAL SCHEDULE OF DEFECTS**

July 2010

Prepared for McCullough Mulvin Architects

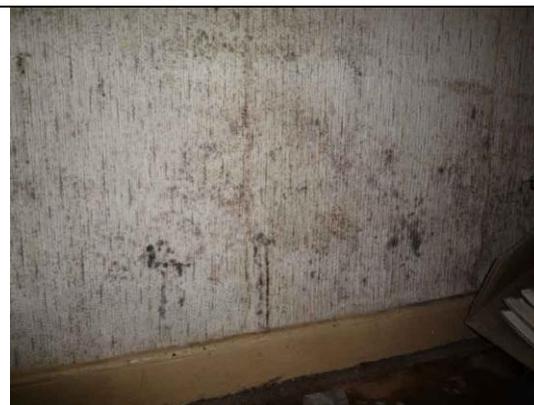
Fig.4: Rising damp at low level indicating excessive levels of moisture within the structure.

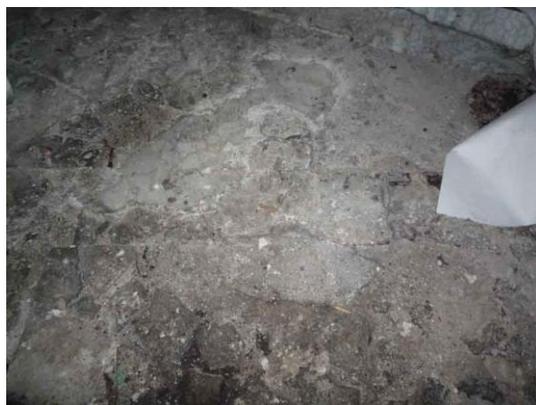
Fig.13: Broken-up concrete floor.

Condition	Recommendations
Floor	Broken concrete floor.	Remove concrete and pour new subfloor incorporating dpc.
Walls	Missing skirting.	Replace missing sections of timber skirting to match that at G05.
Door	Missing door knob.	Where door knobs are missing these should be replaced in brass.
Rising Damp	Rising damp to walls.	Rake-out cement based strap pointing to external walls. Re-point and re-harl external walls in a lime based material. Rationalise external drainage and introduce a French drain to reduce likelihood of rising damp. Gradually introduce heating to the building ensuring adequate ventilation of all rooms.

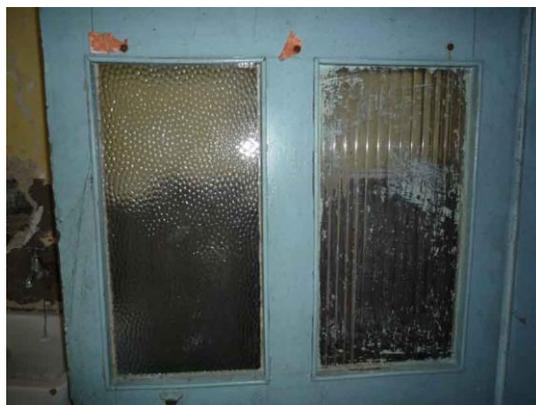
Fig.17: Glazed panels to the door giving access to G08.

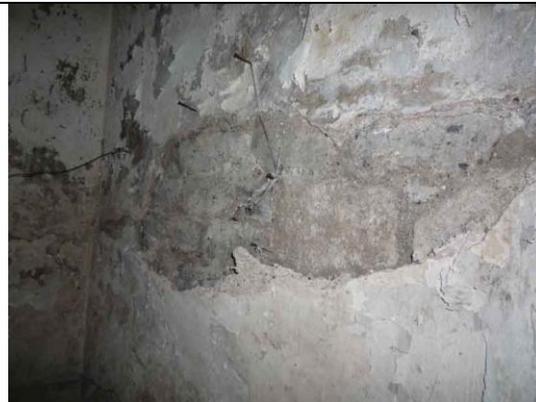
Fig.19: Failed plaster to the west wall.

Condition	Recommendations
Floor	Broken concrete floor.	Remove concrete and pour new subfloor incorporating dpc.
Walls	Delamination and loss of plaster to walls.	Rake-out cement based strap pointing to external walls and re-point in a lime based material. Re-harl all external walls in a lime based material. Rationalise external drainage and introduce a French drain to reduce likelihood of rising damp. Replace damaged/missing sections of plaster with a lime based plaster to match existing.
	Missing skirting.	Replace missing sections of timber skirting to match that at G01.
Ceiling	Localised hairline and larger cracks running west-east.	Cracks to be caulked with a mixture of lime putty and casting plaster.
Door	20 th century ironmongery (locks, latches, hooks etc.) fitted to door.	Original door furniture should be retained and later fittings removed. Where door knobs are missing these should be replaced in brass.

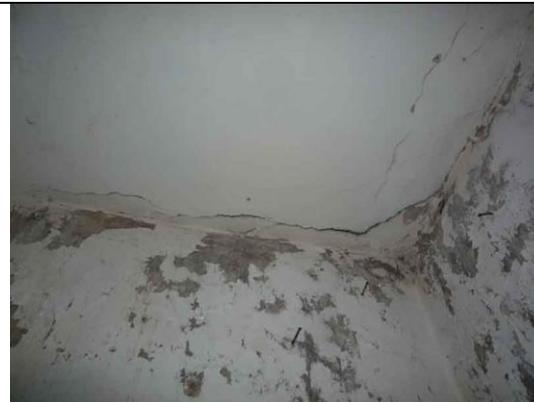
Fig.20: Cracking to ceiling at junction with south wall.

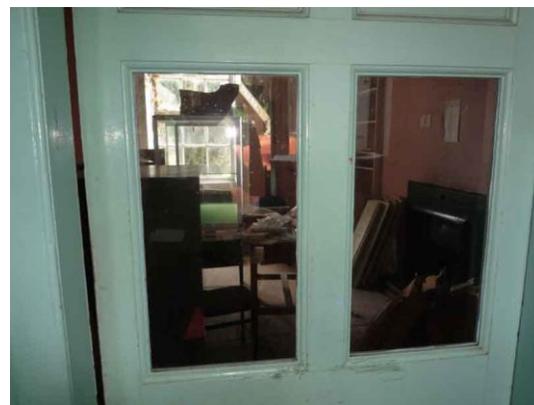
Fig.24: Glazed panels to the door giving access to G13.

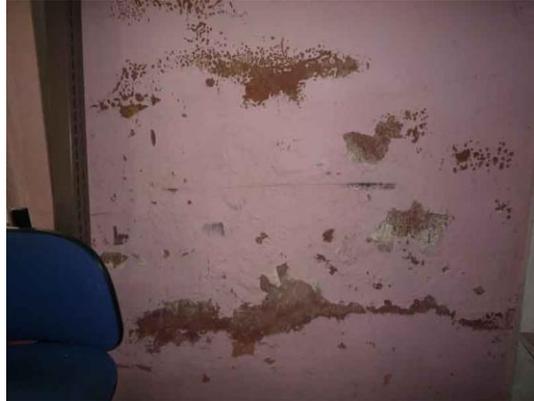
Fig.25: Plaster failure to the east wall indicating rising damp.

Condition	Recommendations
Floor	Linoleum over concrete floor.	Remove concrete and pour new subfloor incorporating dpc.
Walls	Delamination and efflorescence of plaster at low level to east wall and chimney breast.	Rake-out cement based strap pointing to external walls. Re-point and re-harl external walls in a lime based material. Rationalise external drainage and introduce a French drain to reduce likelihood of rising damp. Cap chimney flue to prevent the ingress of rainwater while allowing adequate ventilation. Replace damaged/missing sections of plaster with a lime based plaster to match existing.
Doors	Glazed panels to door giving access to G12.	Replacing the glazed panels with timber.
	20 th century ironmongery (locks, latches, hooks etc.) fitted to door.	Original door furniture should be retained and later fittings removed. Where door knobs are missing these should be replaced in brass.
Window	Sash window not operable.	Refurbish sash windows ensuring weights are correctly counter balanced and window is operable.

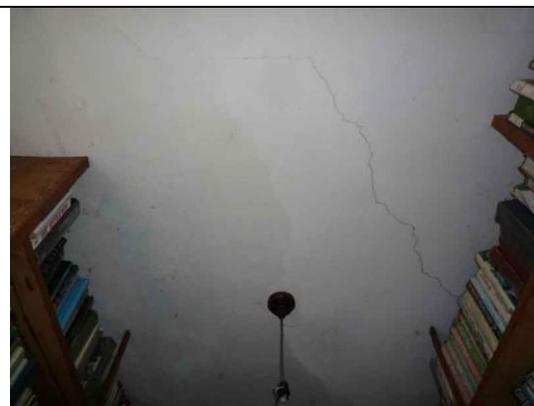
Fig.31: Cracking of ceiling plaster.

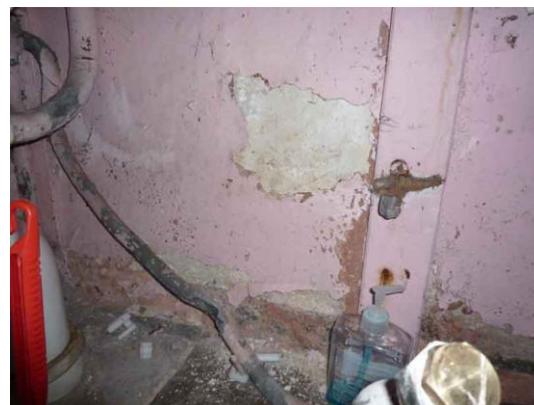
Fig.35: Effloresce and rising damp at low level to the west wall.

Condition	Recommendations
Floor	Linoleum over concrete floor.	Remove concrete and pour new subfloor incorporating dpc.
Walls	Delamination and efflorescence of plaster to west wall.	Rake-out cement based strap pointing to external walls. Re-point and re-harl external walls in a lime based material. Rationalise external drainage and introduce a French drain to reduce likelihood of rising damp. Replace damaged/missing sections of plaster with a lime based plaster to match existing.
	Late 20 th century timber and glazed partition wall to north.	Removing the timber and glazed partition wall to reinstate the original room proportions.
	Missing skirting.	Replace missing sections of timber skirting to match that at G16.
Doors	Blocked door opening to south wall.	Re-instate original opening and install a double-leaf timber panelled door with architrave to match the doorway in G12 giving access to G11.
Rising Damp	Rising damp to walls.	Rake-out cement based strap pointing to external walls. Re-point and re-harl external walls in a lime based material. Rationalise external drainage and introduce a French drain to reduce likelihood of rising damp. Gradually introduce heating to the building ensuring adequate ventilation of all rooms.

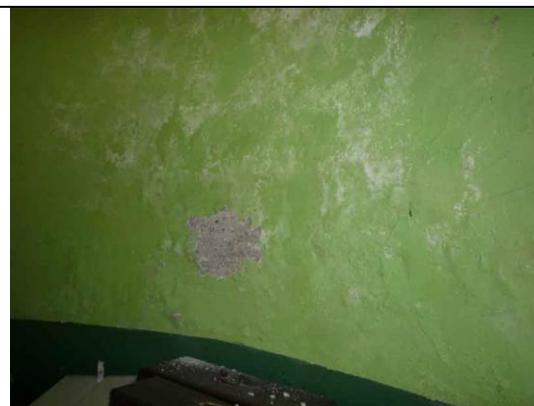
Fig.37: Efflorescence and plaster failure to east wall.

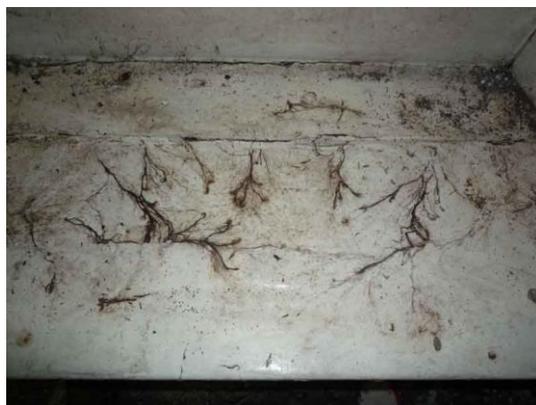
Fig.40: Fungal growth to window cill to easternmost opening.

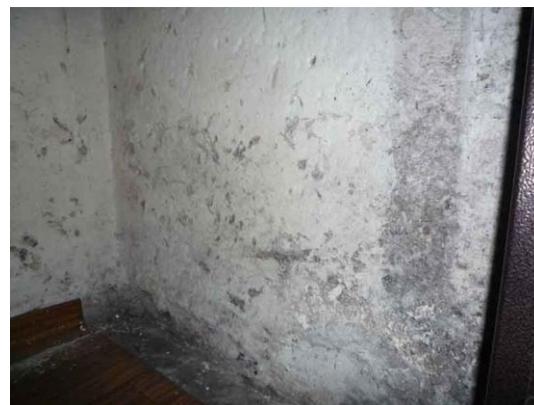
Fig.44: Rising damp to the west wall.

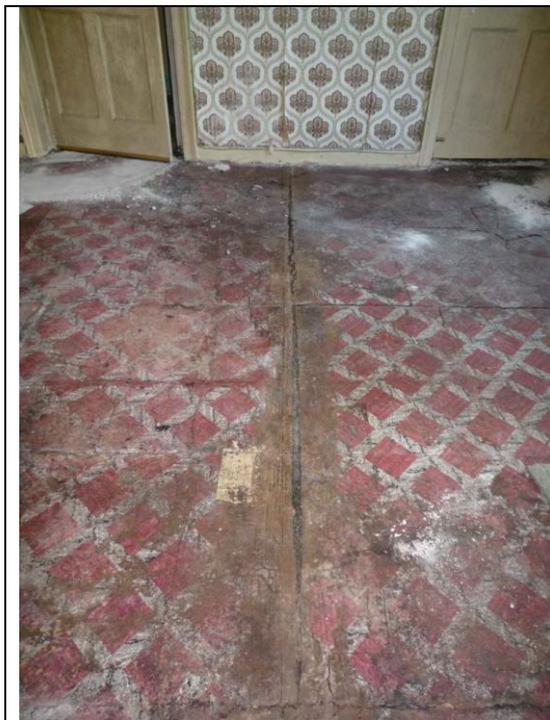
Fig.45: Linoleum floor covering to the limestone flags.

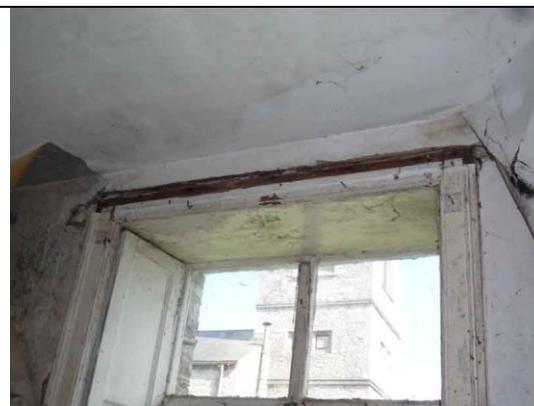
Fig.48: Missing section of architrave to window opening.

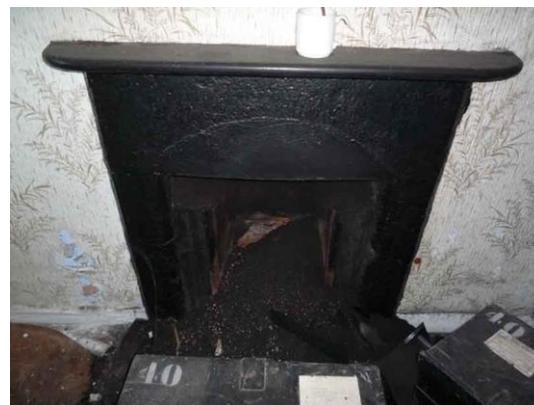
Fig.52: Detritus from nesting birds to the fireplace.

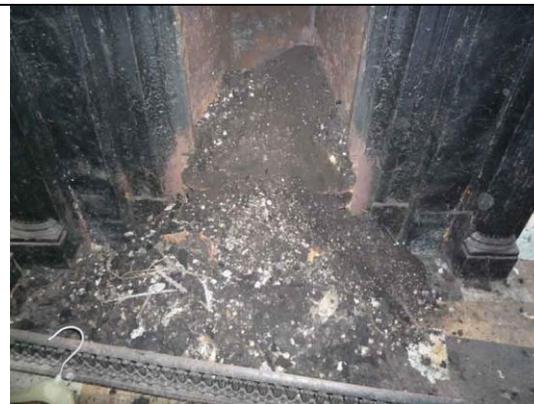
Fig.54: Evidence of detritus from nesting birds in grate.

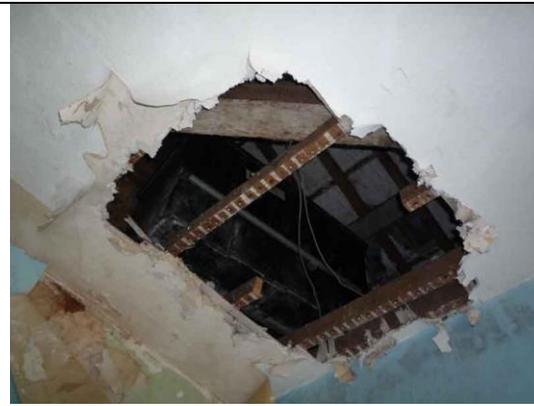
Fig.56: Hole in ceiling plasterwork to the southeast.

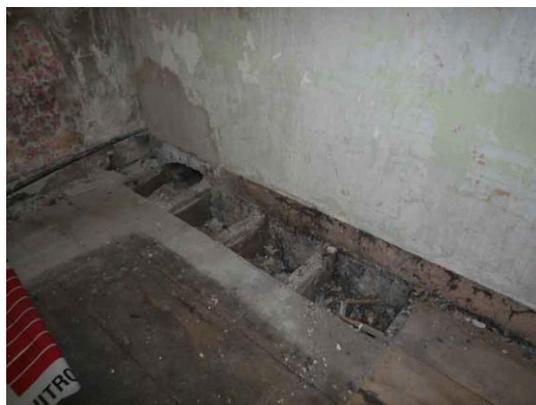
Fig.57: Missing timber floorboards to east.

Condition	Recommendations
Floor	Localised area of missing floorboards to the east and west.	Original boards should be re-seated where these have been lifted to facilitate works. New boards to match existing should be seated where existing boards are missing/damaged beyond reuse.
Walls	Boast plaster to north wall.	Rake-out cement based strap pointing to external walls. Re-point and re-harl external walls in a lime based material. Rationalise external drainage and introduce a French drain to reduce likelihood of rising damp. Replace boast sections of plaster with a lime based plaster to match existing.
	Diagonal cracking of plaster to west wall (running diagonally from floor to ceiling and horizontally at ceiling level). Possibly relating to structural cracking recorded at ground level to north elevation.	Structural engineer to investigate & underlying causes to be addressed prior to repair of plasterwork. Cracks to be caulked with a mixture of lime putty and casting plaster.

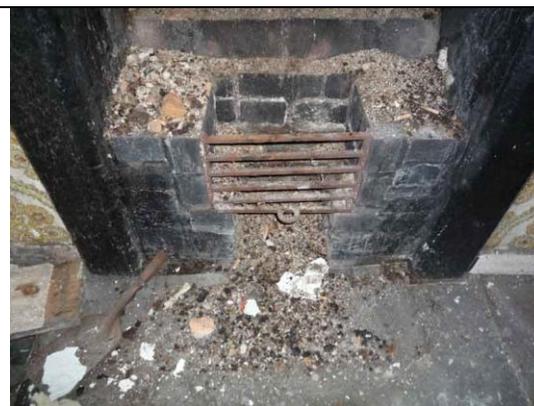
Fig.60: Over-painted fireplace. Note the detritus to opening.

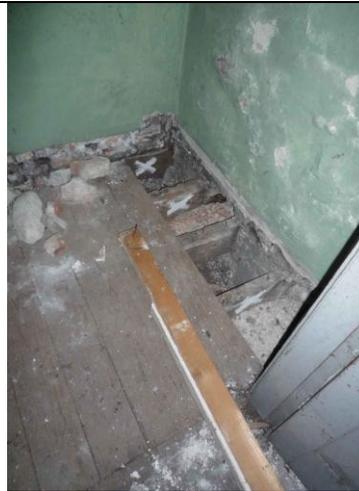
Fig.66: Missing floorboards, timber skirting and failed plaster to room F07.

Condition	Recommendations
Floor	Localised area of missing and damaged floorboards to the south.	Original boards should be re-seated where these have been lifted to facilitate works. New boards to match existing should be seated where existing boards are missing/damaged beyond reuse.
	Timber decay recorded to bearing ends of floor joists.	Cut out damaged/decayed timber and splice in new pressure treated timber to match existing. Where bearing ends are replaced consideration should be given to introducing a damp proof barrier.
Walls	Missing skirting.	Replace missing sections of timber skirting to match that at G05.
	Delamination/loss of plaster to walls.	Re-point and re-harl external walls in a lime based material. Replace damaged/missing sections of plaster with a lime based plaster to match existing.
Doors	20 th century ironmongery (locks, latches, hooks etc.) fitted to door.	Original door furniture should be retained and later fittings removed. Where door knobs are missing these should be replaced in brass.

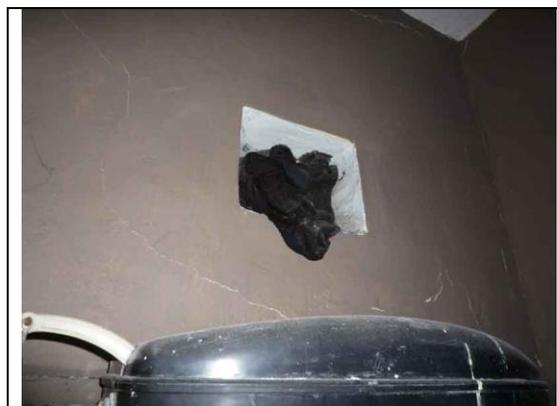
Fig.69: Vent to the south wall.

Condition	Recommendations
Floor	Linoleum floor covering.	Remove linoleum and re-survey floor.
Walls	Delamination and loss of plaster to south wall.	Rake-out cement based strap pointing to external walls and re-point in a lime based material. Re-harl all external walls in a lime based material. Replace damaged/missing sections of plaster with a lime based plaster to match existing.
	Missing skirting.	Replace missing sections of timber skirting to match that at F01.
Door	20 th century ironmongery (locks, latches, hooks etc.) fitted to door.	Original door furniture should be retained and later fittings removed. Where door knobs are missing these should be replaced in brass.
	Glazed panels to door.	Replace the glazed panels with timber.
Other	Vent to south wall.	Ventilation of this room should be reconsidered to allow the vent in the south wall to be blocked as this detracts from the visual aesthetics of the blind opening to the external elevation.

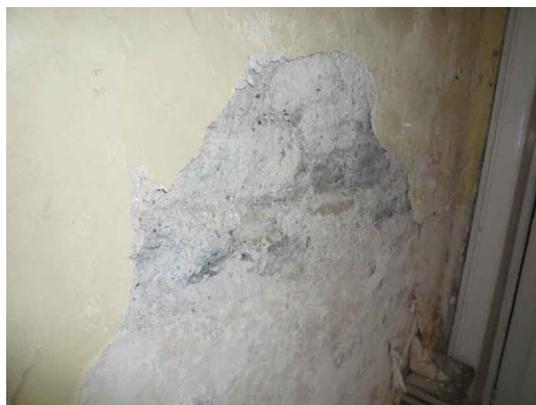
Fig.74: Failed plaster to the west wall.

Condition	Recommendations
Floor	Linoleum floor covering.	Remove linoleum and re-survey floor.
Walls	Delamination and loss of plaster to south and west walls.	Rake-out cement based strap pointing to external walls and re-point in a lime based material. Re-harl all external walls in a lime based material. Replace damaged/missing sections of plaster with a lime based plaster to match existing.
	Cracking of plaster to north wall over doorway giving access to F11 (possibly relating to a relieving arch).	Cracks to be caulked with a mixture of lime putty and casting plaster.
Ceiling	Missing section of ceiling plasterwork to southeast corner.	Check timber ceiling joists for decay and replace where necessary. Repair ceiling using natural lime based plaster to match existing.
Window	Inappropriate timber casement window exhibiting wet rot, broken joints and missing glazing.	Replace window unit with timber six-over-six sash window to match window located in room F13. Timber must be pressure treated to resist decay.

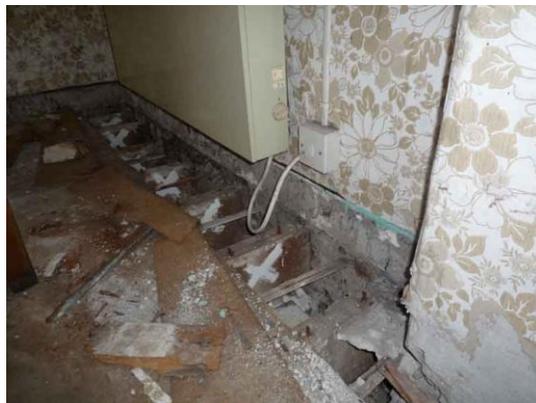
Fig.80: Missing floorboards to south wall.

Condition	Recommendations
Floor	Linoleum floor covering.	Remove linoleum and re-survey floor.
	Localised area of missing and damaged floorboards to the northwest and southwest.	Original boards should be re-seated where these have been lifted to facilitate works. New boards to match existing should be seated where existing boards are missing/damaged beyond reuse.
	Timber decay recorded to bearing ends of floor joists.	Cut out damaged/decayed timber and splice in new pressure treated timber to match existing. Where bearing ends are replaced consideration should be given to introducing a damp proof barrier.
Walls	Holes in all walls to facilitate investigation of timber lintels.	Replace damaged/missing sections of plaster with a lime based plaster to match existing.
	Delamination of plaster at junction of south and west walls.	Rake-out cement based strap pointing to external walls. Re-point and re-harl external walls in a lime based material. Replace damaged/missing sections of plaster with a lime based plaster to match existing.

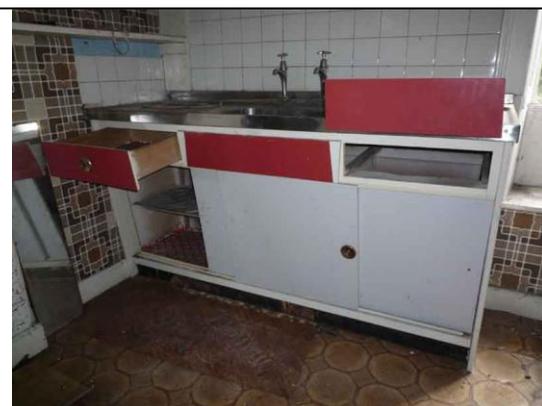
Fig.85: Built-in timber kitchen units.

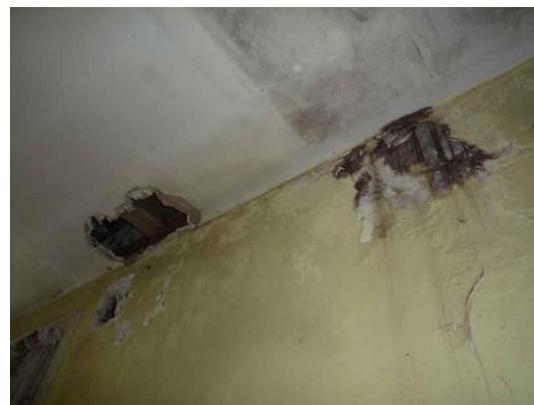
Fig.90: Hole in ceiling and penetrating damp at high level to north wall.

Condition	Recommendations
Floor	Localised area of missing and damaged floorboards to the north.	Original boards should be re-seated where these have been lifted to facilitate works. New boards to match existing should be seated where existing boards are missing/damaged beyond reuse.
	Timber decay recorded to bearing ends of floor joists.	Cut out damaged/decayed timber and splice in new pressure treated timber to match existing. Where bearing ends are replaced consideration should be given to introducing a damp proof barrier.
Wall	Cracking of plaster to south wall.	Cracks to be caulked with a mixture of lime putty and casting plaster.
	Missing skirting to north wall.	Replace missing sections of timber skirting to match existing.
	Holes in north wall to facilitate investigation of timber lintels.	Replace damaged/missing sections of plaster with a lime based plaster to match existing.
Doors	Glazed panels to door giving access to F20.	Replace missing sections of timber skirting to match existing.

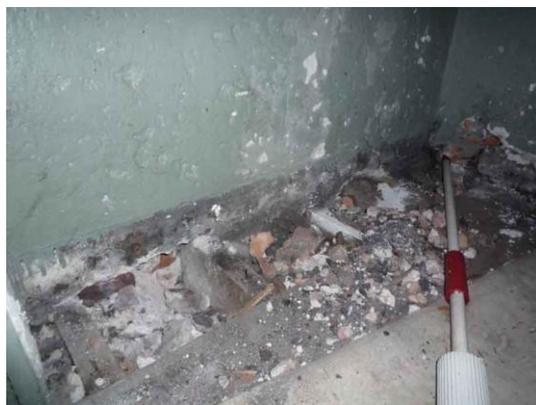
Fig.91: Missing floorboards to the north wall.

Condition	Recommendations
Floor	Localised area of missing and damaged floorboards to the north.	Original boards should be re-seated where these have been lifted to facilitate works. New boards to match existing should be seated where existing boards are missing/damaged beyond reuse.
	Timber decay recorded to bearing ends of floor joists.	Cut out damaged/decayed timber and splice in new pressure treated timber to match existing. Where bearing ends are replaced consideration should be given to introducing a damp proof barrier.
Walls	Missing skirting.	Replace missing sections of timber skirting to match that at F28.
	Delamination/loss of plaster to walls.	Re-point and re-harl external walls in a lime based material. Replace damaged/missing sections of plaster with a lime based plaster to match existing.
Doors	20 th century ironmongery (locks, latches, hooks etc.) fitted to door.	Original door furniture should be retained and later fittings removed. Where door knobs are missing these should be replaced in brass.

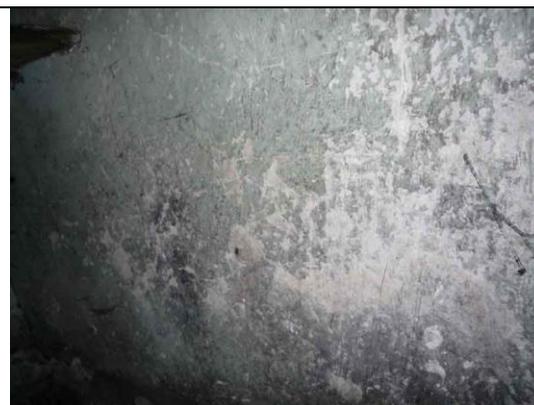
Fig.94: Penetrating damp to the east wall.

Condition	Recommendations
Floor	Localised area of missing and damaged floorboards to the north.	Original boards should be re-seated where these have been lifted to facilitate works. New boards to match existing should be seated where existing boards are missing/damaged beyond reuse.
	Timber decay recorded to bearing ends of floor joists.	Cut out damaged/decayed timber and splice in new pressure treated timber to match existing. Where bearing ends are replaced consideration should be given to introducing a damp proof barrier.
Walls	Missing skirting.	Replace missing sections of timber skirting to match that at F28.
	Delamination/loss of plaster to walls.	Re-point and re-harl external walls in a lime based material. Replace damaged/missing sections of plaster with a lime based plaster to match existing.
Doors	20 th century ironmongery (locks, latches, hooks etc.) fitted to door.	Original door furniture should be retained and later fittings removed. Where door knobs are missing these should be replaced in brass.

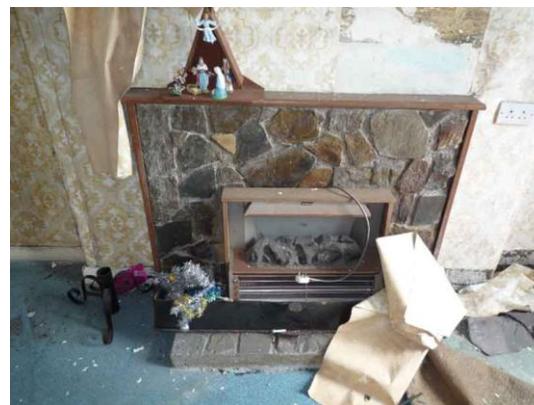
Fig.98: Modern fireplace to east wall.

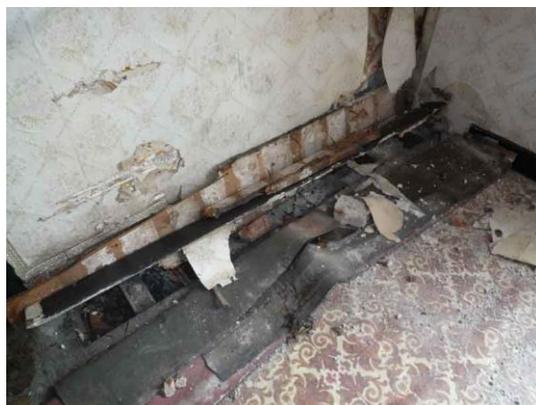
Fig.99: Missing timber floorboards to the east wall.

Condition	Recommendations
Floor	Localised area of missing and damaged floorboards to the east.	Original boards should be re-seated where these have been lifted to facilitate works. New boards to match existing should be seated where existing boards are missing/damaged beyond reuse.
Walls	Delamination/loss of plaster to south walls.	Re-point and re-harl external walls in a lime based material. Replace damaged/missing sections of plaster with a lime based plaster to match existing.
	Dry lining to south walls.	Remove dry lining - allow walls to dry out and re-survey. Rake-out cement based strap pointing to external walls. Re-point and re-harl external walls in a lime based material.
Window	Inappropriate timber casement window exhibiting wet rot and missing glazing.	Replace window unit with timber six-over-six sash window to match window located in room F13. Timber must be pressure treated to resist decay.

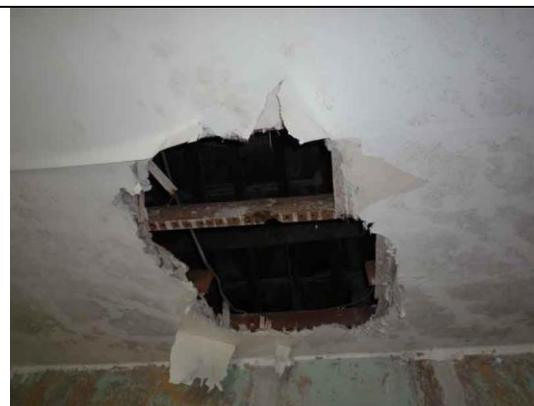
Fig.102: Hole to ceiling plaster.

Condition	Recommendations
Floor	Localised area of missing and damaged floorboards to the southeast.	Original boards should be re-seated where these have been lifted to facilitate works. New boards to match existing should be seated where existing boards are missing/damaged beyond reuse.
	Timber decay recorded to bearing ends of floor joists.	Cut out damaged/decayed timber and splice in new pressure treated timber to match existing. Where bearing ends are replaced consideration should be given to introducing a damp proof barrier.
Walls	Missing skirting to east and west.	Replace missing sections of timber skirting to match existing.
	Holes in all walls to facilitate investigation of timber lintels.	Replace damaged/missing sections of plaster with a lime based plaster to match existing.
Ceiling	Missing section of ceiling plasterwork to north.	Check timber ceiling joists for decay and replace where necessary. Replace damaged/missing sections of plaster with a lime based plaster to match existing.

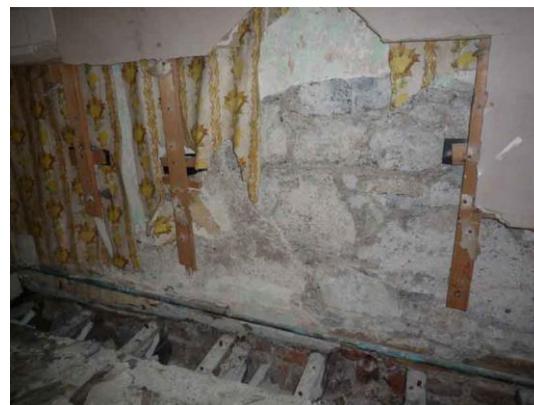
Fig.104: Failed plaster to west wall beneath dry lining.

Condition	Recommendations
Floor	Localised area of missing and damaged floorboards to the west.	Original boards should be re-seated where these have been lifted to facilitate works. New boards to match existing should be seated where existing boards are missing/damaged beyond reuse.
	Timber decay recorded to bearing ends of floor joists.	Cut out damaged/decayed timber and splice in new pressure treated timber to match existing. Where bearing ends are replaced consideration should be given to introducing a damp proof barrier.
Walls	Missing skirting to west.	Replace missing sections of timber skirting to match existing.
	Holes in all walls to facilitate investigation of timber lintels.	Replace damaged/missing sections of plaster with a lime based plaster to match existing.
Door	20 th century ironmongery (locks, latches, hooks etc.) fitted to door.	Original door furniture should be retained and later fittings removed. Where door knobs are missing these should be replaced in brass.
